2004-2010 BMW X3 – Front Lower Ball Joint and Front Lower Forward Control Arm Identification

Brand	Supreme	Product	Control Arm and Ball Joint	Date	January 2020
Part Number(s)	MS10501/MS10547/MS10196/MS10197

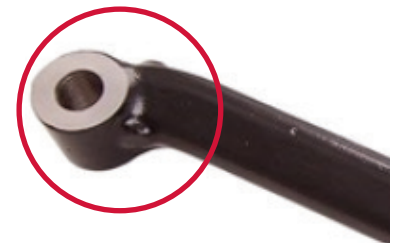
Figure 2: New "Thick Neck" - 2007 and after.

Vehicles built **after** January, 2007 (E83 LCI) will feature the revised "thick neck" control arm. This "thick neck" control arm can only be used with the revised "taller" height ball joint. (See Figure 2)

It is critical to note that these components **cannot be interchanged**.

If replacing a "thin neck" control arm with a "thick neck" control arm, the ball joint must be updated.

If replacing a "shorter" height ball joint with a "taller" height ball joint, the control arm must be updated.

It is also important to note that if replacing with updated components, the replacement should be done in pairs for both sides of the vehicle to retain suspension geometry. Perform vehicle alignment after repair.
