## 2011-2002 Subaru Aluminum Front Lower Control Arm Ball Joint Seating Cone

Brand	TTX/Supreme/Original Grade	Product	Ball Joint and Control Arm	Date	October 2021
Part Number(s)	TXK9513/MK9513/CMS80166/CMS80167/CMS80182/CMS80183/GK9513/GS80166/GS80177

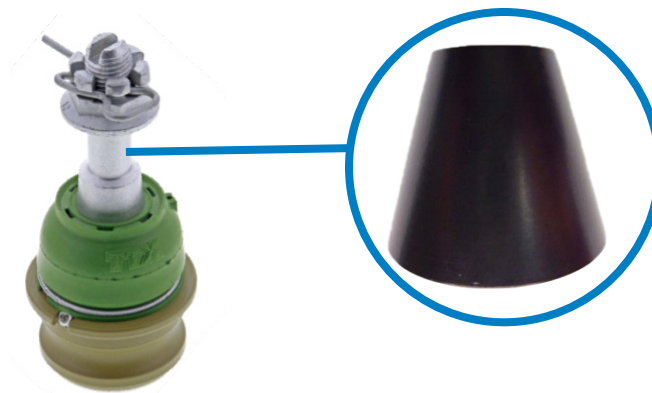
This visual discrepancy can occur if the ball joint seating cone becomes seized to the ball joint stud when removing the aluminum front lower control arm from the original ball joint. **See Figure 1.**

**Figure 1.** Ball seating cone (circled) may become seized to the ball joint stud, causing it to appear different than the Mevotech part. Mevotech replacement ball joints with the part numbers TXK9513/MK9513/GK9513 feature an anti-corrosion coated ball stud to reduce the potential of seizing.

It is important to adhere to factory service manual removal procedures when separating a ball joint from an aluminum control arm that uses a cone. Often, a special tool will be required to retain the cone in the bore as the control arm is being separated from the ball joint.

If the cone must be removed from the ball joint stud for reuse, it must be separated carefully. A combination of penetrating oil and a three-jaw puller will usually suffice. All rust and corrosion must be cleaned from the cone, steering knuckle and control arm bore. Additionally, the cone and mating component must be inspected for damage and/or an 'out-of-round' condition. Do not reuse the cone or mating component if signs of damage or abnormal wear are found.
