BMW Front Lower Thrust Arm Bushings

Brand	Supreme	Product	Control Arm Bushings	Date	January 2020
Part Number(s)	Various

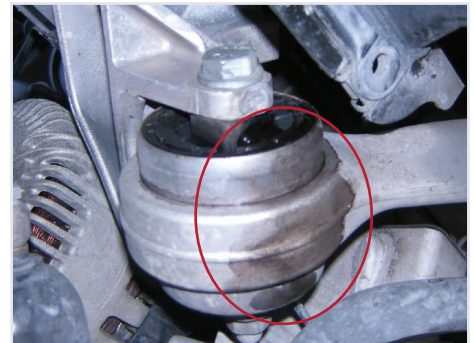
It is up to the technician to determine if the entire thrust arm must be replaced due to excessive “play” in the ball joint or if just the bushings are to be renewed. Generally, the bushing rubber will crack and tear. Additionally, on some BMW models, this bushing is filled with a hydraulic fluid; which will leak once the rubber has torn. These failure modes can be verified by a visual inspection. Do note that solely manipulating the wheels and thrust arm for “play” may not indicate thrust arm bushing failure; both worn and new bushings may appear to have similar movements.

Figure 1: Hydraulic fluid leaking from bushing. One indicator of failed bushing.

To successfully replace the thrust arm bushing and ensure maximum part life, it is important to adhere to the following:

- ⚙️ Thrust arm bushings must be replaced in pairs.
- ⚙️ Thrust arm bushings cannot be replaced more than once on an arm. This is due to enlargement of the bore. If a vehicle encounters repeated bushing failures in a short span of time, inspect for wear, distortion/damage to suspension components and verify vehicle alignment.
- ⚙️ Use the factory tool for removal and installation. Aftermarket tools may not have the correctly sized press/receiver cups which may warp or otherwise damage the thrust arm bore.
- ⚙️ The factory tool will help ensure the bushing is even and square on the proper install axis. Correct seating and alignment are critical to part life longevity.

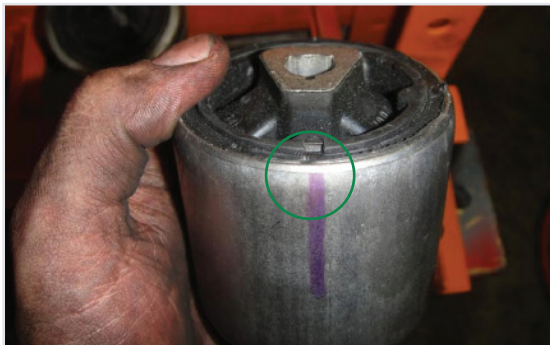
Figure 1: One type of clocking indicator

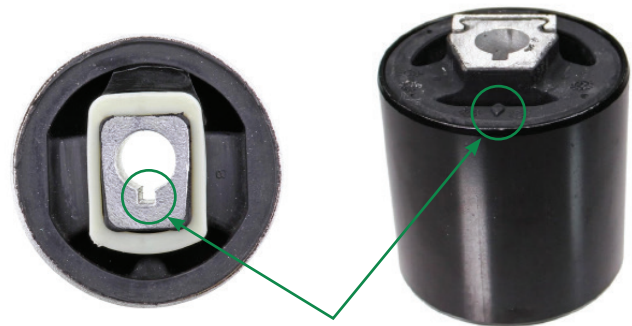
Figure 2: Examples of Clocking Indicators

Clocking indicator must match raised tab on arm
