Correct Installation Orientation: 2000-1995 GM 1500 Truck and 2500/3500 SUV Front Lower Ball Joint (Stamped Steel Arm)

Brand	TTX	Product	Ball Joint	Date	April 2023
Part Number(s)	TXK6477

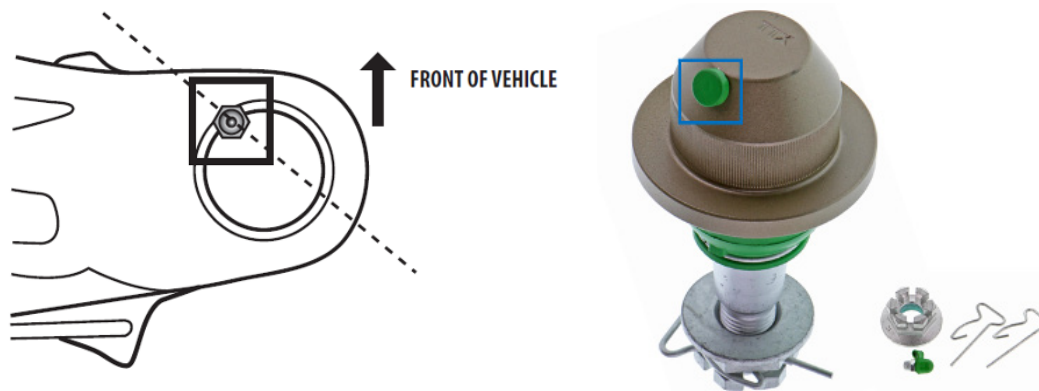
Figure 1. To ensure adequate clearance between components for relubrication service, ball joint must be installed with grease fitting positioned approximately 45° towards centerline of vehicle.

- Before installation of ball joint, ensure all mating surfaces are clear of rust, debris and burrs.
- Verify press-in diameters and stud tolerances, including on steering knuckle side. Inspect mating surfaces for cracks, deformation and or an out of round condition. Replace all damaged or out-of-specification mating components.
- Correct orientation is achieved when grease fitting is located approximately 45° towards centerline of vehicle. Grease fitting must also be positioned towards front of vehicle. **See Figure 1.**
- Before press-in, it is recommended to create an index mark on both the control arm body and ball joint housing using a suitable implement, such as a grease pencil. This will assist in attaining correct orientation during press-in.
