Correct Installation Orientation: 2000-1996 GM 1500 Truck & 2500/3500 SUV Front Lower Ball Joint (Forged Arm)

Brand	Supreme	Product	Ball Joint	Date	April 2023
Part Number(s)	MK6509

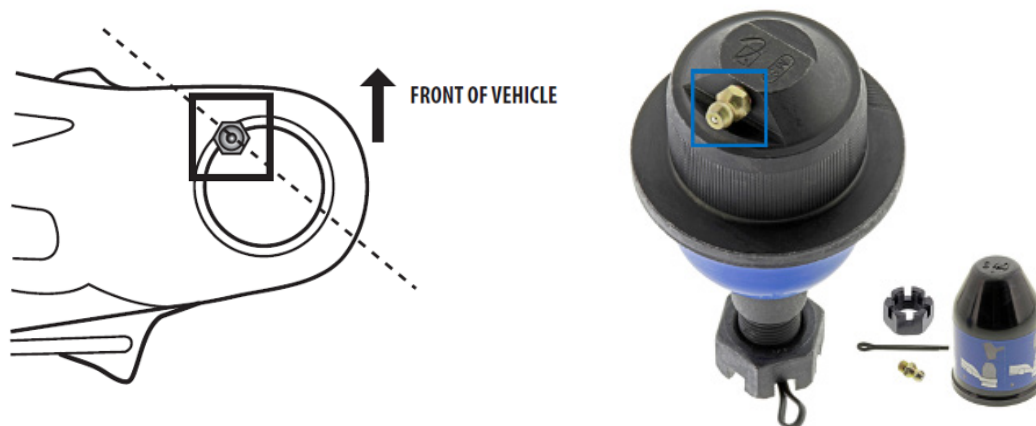
To ensure adequate access to the grease fitting for relubrication service, the below noted ball joint must be pressed-in using the correct orientation.

Figure 1. To ensure adequate clearance between components for relubrication service, ball joint must be installed with grease fitting positioned approximately 45° towards centerline of vehicle. A Bootstaller™ tool is included in the box to seat the dust boot securely and easily safter install.
