## Correct Installation Orientation: 2000-1996 GM 1500 Truck and 2500/3500 SUV Front Lower Ball Joint (Forged Arm)

Brand	TTX	Product	Ball Joint	Date	April 2023
Part Number(s)	TXMS50570

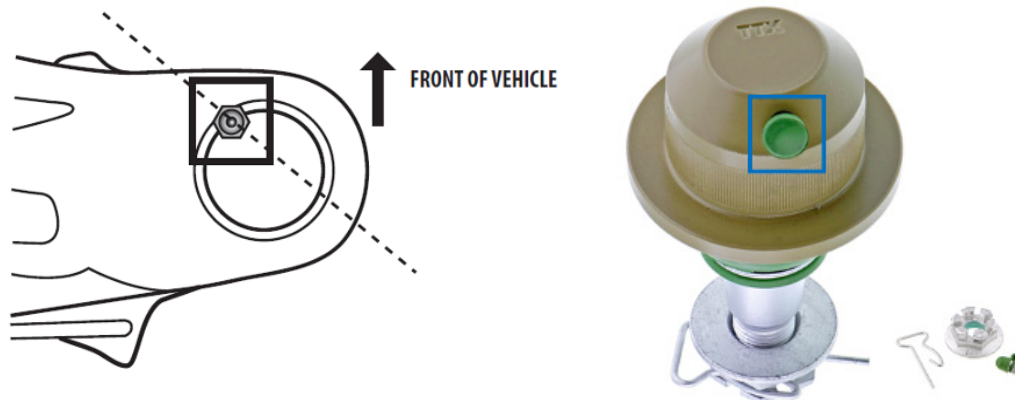
To ensure adequate access to the grease fitting for relubrication service, the below noted ball joint must be pressed-in using the correct orientation.

**Figure 1.** To ensure adequate clearance between components for relubrication service, ball joint must be installed with grease fitting positioned approximately 45° towards centerline of vehicle.

- Before installation of ball joint, ensure all mating surfaces are clear of rust, debris and burrs.
- Verify press-in diameters and stud tolerances, including on steering knuckle side. Inspect mating surfaces for cracks, deformation and or an out of round condition. Replace all damaged or out-of-specification mating components.
- Correct orientation is achieved when grease fitting is located approximately 45° towards centerline of vehicle. Grease fitting must also be positioned towards front of vehicle. **See Figure 1.**
- Before press-in, it is recommended to create an index mark on both the control arm body and ball joint housing using a suitable implement, such as a grease pencil. This will assist in attaining correct orientation during press-in.
