Correct Installation Orientation – 2008-2003 Honda & Acura Front Upper Ball Joint

Brand	Original Grade/Supreme	Product	Ball Joint	Date	June 2021
Part Number(s)	GK80199/MK80199

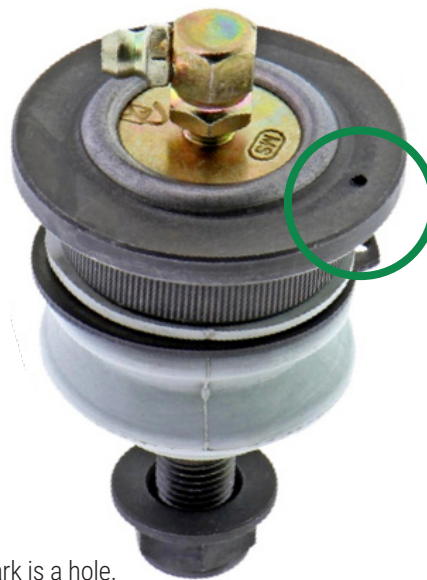
Figure 1. Ball joint index mark. In this example, the index mark is a hole.

- Locate ball joint index mark. This may take the form of a hole, dimple, tab, notch or arrow. **See Figure 1.**
- Locate control arm index mark. This may take the form of a hole, dimple, tab, notch or arrow. **See Figure 2.**
- Do not contact ball joint backing plate during press-in.
- Ball joint index mark must align with control arm side index mark during installation. **See Figure 3.**

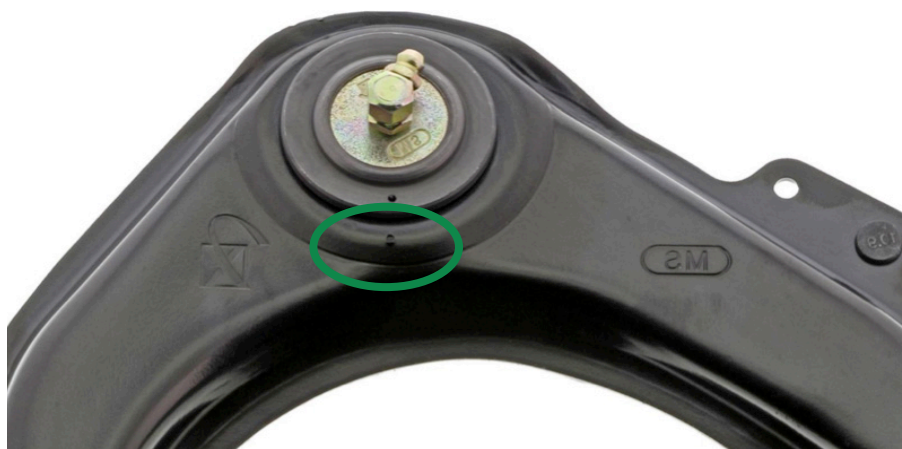
Figure 2. Control arm index mark. In this example, the index mark is a hole.

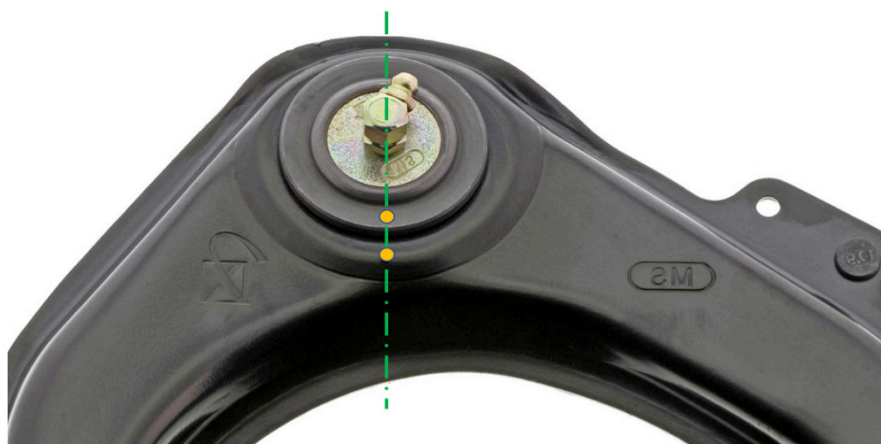
The identified part numbers are directional type ball joints; wherein they are designed to allow for an increased swing angle in a particular direction. Incorrect installation orientation of directional type ball joints may permit over travel of the ball stud in the improper direction, resulting in contact with the ball joint housing.

Figure 3. Correct installation orientation is achieved when ball joint index mark aligns with control arm side index mark.
