Correct Installation Orientation: 2010-1999 GM 1500-2500-3500 Truck Front Lower Ball Joint

Brand	TTX	Product	Ball Joint	Date	November 2022
Part Number(s)	TXK6693

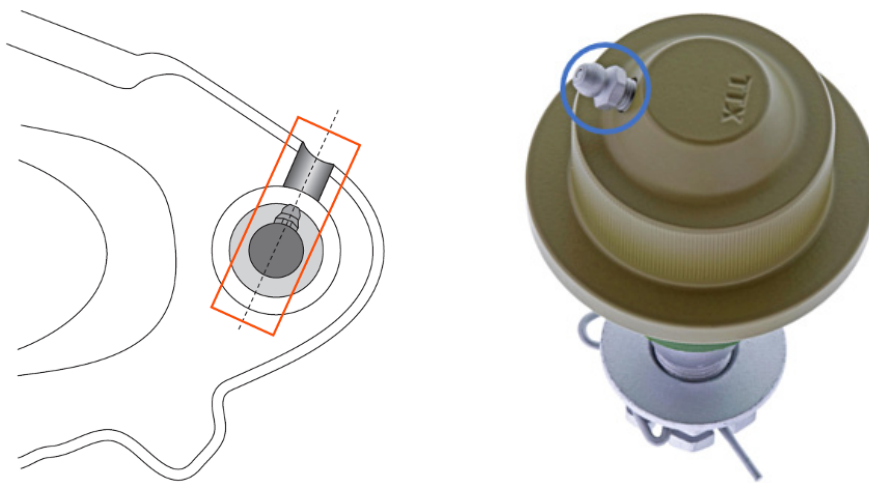
Figure 1. To ensure adequate clearance between components and accessibility for future relubrication service, ball joint must be installed with grease fitting in alignment to channel groove on front lower control arm

- Before installation of ball joint, ensure all mating surfaces are clear of rust, debris and burrs.
- Verify press-in diameters and stud tolerances, including on steering knuckle side. Inspect mating surfaces for cracks, deformation and or an out of round condition. Replace all damaged or out-of-specification mating components.
- The ball joint must be installed with the grease fitting in alignment to channel groove on front lower control arm. **See Figure 1.**
- Before press-in, it is recommended to create an index mark on both the control arm and ball joint housing using a suitable implement, such as a grease pencil. This will assist in attaining correct orientation during press-in.
