Correct Installation Orientation: 2010-1999 GM 1500/2500/3500 Truck Front Lower Ball Joint

Brand	Supreme	Product	Ball Joint	Date	November 2022
Part Number(s)	MK6693

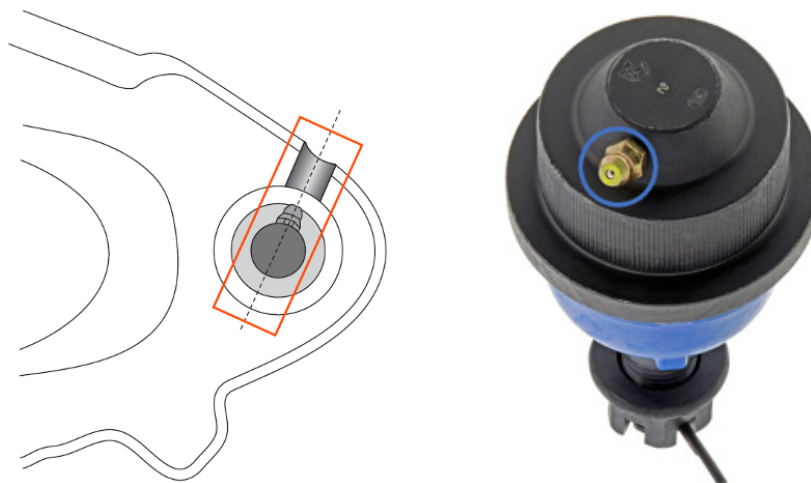
Figure 1. To ensure adequate clearance between components and accessibility for future relubrication service, ball joint must be installed with grease fitting in alignment to channel groove on front lower control arm

To ensure adequate access to the grease fitting, the below noted ball joint must be pressed-in using the correct orientation.

- Before installation of ball joint, ensure all mating surfaces are clear of rust, debris and burrs.
- Verify press-in diameters and stud tolerances, including on steering knuckle side. Inspect mating surfaces for cracks, deformation and or an out of round condition. Replace all damaged or out-of-specification mating components.
- The ball joint must be installed with the grease fitting in alignment to channel groove on front lower control arm. **See Figure 1.**
- Before press-in, it is recommended to create an index mark on both the control arm and ball joint housing using a suitable implement, such as a grease pencil. This will assist in attaining correct orientation during press-in.
