## Correct Installation Orientation- 2011-2003 Ford Full-Size Sedan Front Upper Ball Joint (Forged Arm)

<b>Brand</b>	Supreme	<b>Product</b>	Ball Joint	<b>Date</b>	September 2022
<b>Part Number(s)</b>	MK80272

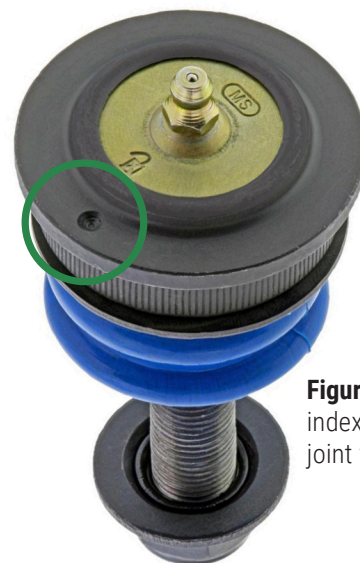
Figure 2. Drilled index mark on ball joint flange (circled)

- Verify press-in diameters and stud tolerances, including on steering knuckle side. Replace all damaged or out-of-specification mating components.
- When pressing-in ball joint, ensure pressure is applied to the mounting flange and not the ball joint back plate. Contact with the back plate during install may lead to damage and or impaired performance of the ball joint.
- Locate drilled index mark on ball joint flange. **See Figure 2.**

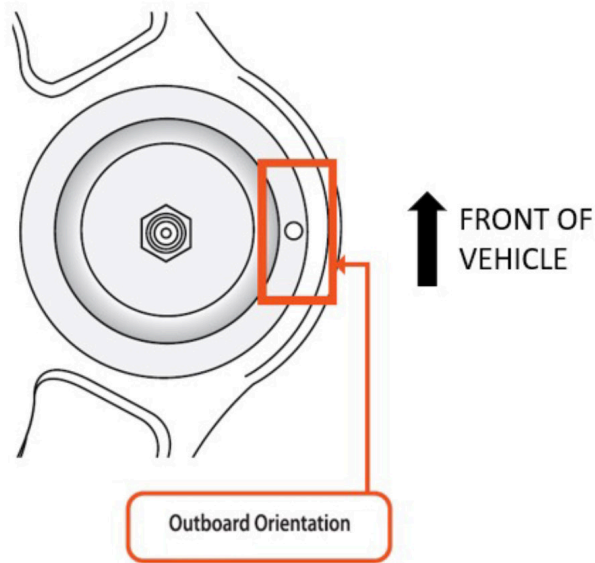
**Figure 3.** Correct ball joint installation orientation when mated to front upper forged steel control arm. Note drilled index mark position (highlighted orange box)

- During press-in, index mark must be oriented so that it is perpendicular to the wheel (facing outboard). For an illustration of correct installation orientation, **see Figure 3.**
