Correct Installation Orientation- 2013-2003 Ford and Mazda Mid-Size Sedan Front Upper Ball Joint

Brand	Supreme	Product	Ball Joint	Date	September 2022
Part Number(s)	MS76500

Part Number(s):
MS76500

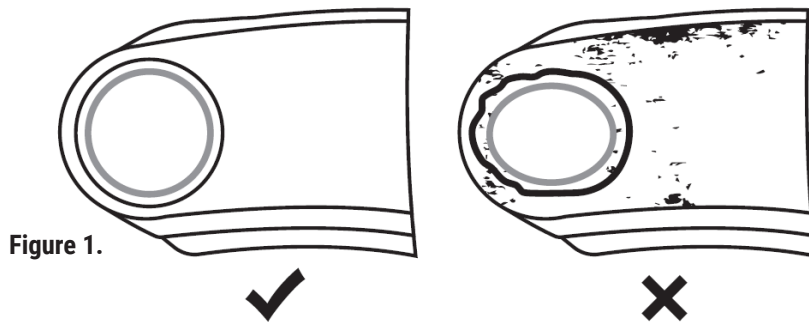
Figure 1.

- Before installation of ball joint, ensure all mating surfaces are clear of rust, debris and burrs. Inspect control arm mounting flange for cracks, deformation and or an out of round condition. Do not reuse control arm body if these are found. **See Figure 1.**

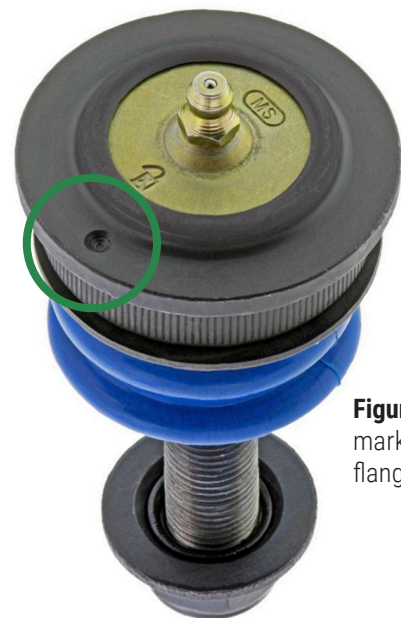
Figure 2. Drilled index mark on ball joint flange (circled)

- Verify press-in diameters and stud tolerances, including on steering knuckle side. Replace all damaged or out-of-specification mating components.
- When pressing-in ball joint, ensure pressure is applied to the mounting flange and not the ball joint back plate. Contact with the back plate during install may lead to damage and or impaired performance of the ball joint.
- Locate drilled index mark on ball joint flange. **See Figure 2.**
