Correct Installation Orientation – 2014-1988 Honda & Acura Front and Rear Upper Ball Joint

Brand	Original Grade/Supreme /TTX	Product	Ball Joint	Date	June 2021
Part Number(s)	GK90336/MK90336/TXK90336

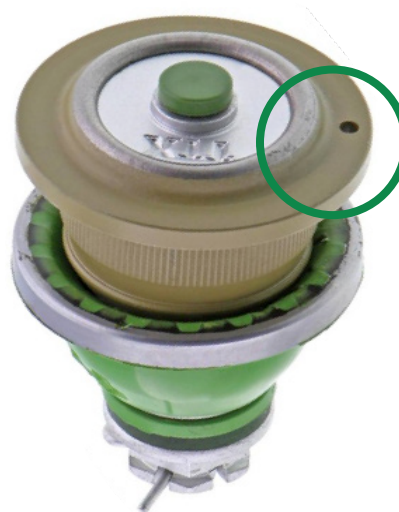
Figure 1. Ball joint index mark. In this example, the index mark is a hole.

- Locate ball joint index mark. This may take the form of a hole, dimple, tab, notch or arrow. **See Figure 1.**
- Locate control arm index mark. This may take the form of a hole, dimple, tab, notch or arrow. **See Figure 2.**
- Do not contact ball joint backing plate during press-in.
- Ball joint index mark must align with control arm side index mark during installation. **See Figure 3.**

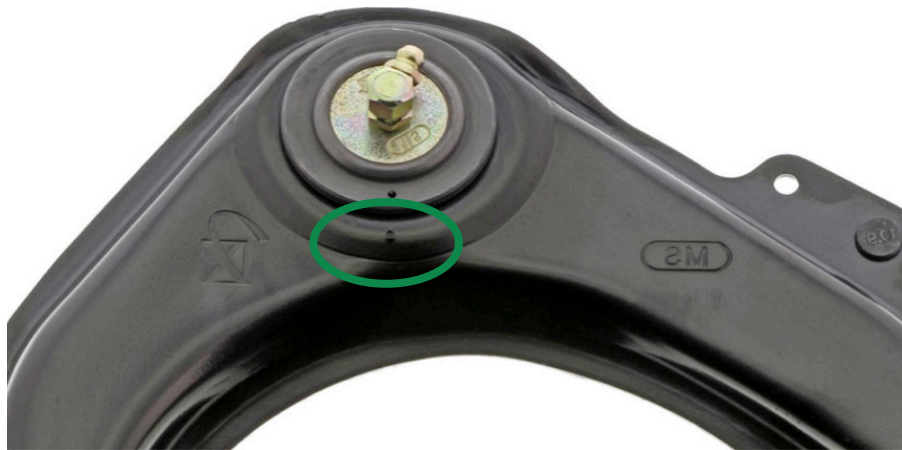
Figure 2. Control arm index mark. In this example, the index mark is a hole.

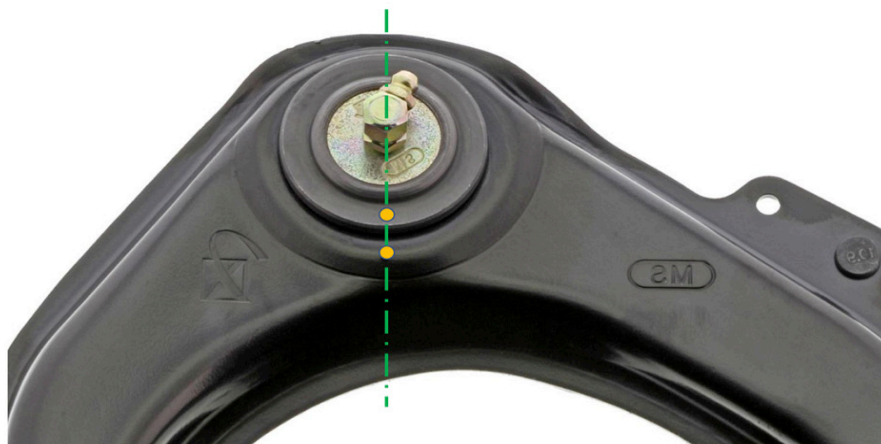
Figure 3. Correct installation orientation is achieved when ball joint index mark aligns with control arm side index mark.
