Correct Installation Orientation – 2014-1991 Honda & Acura Front Upper Ball Joint

Brand	Original Grade/Supreme	Product	Ball Joint	Date	June 2021
Part Number(s)	GK90469/MK90469

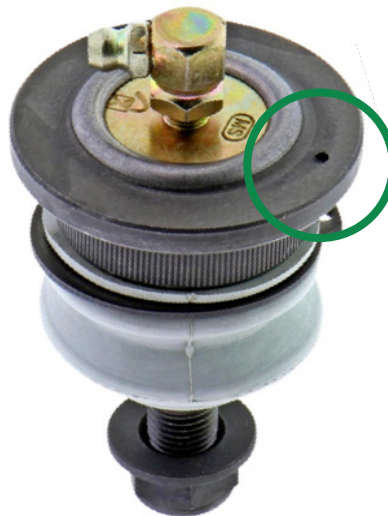
Figure 1. Ball joint index mark. In this example, the index mark is a hole.

- Locate ball joint index mark. This may take the form of a hole, dimple, tab, notch or arrow. **See Figure 1.**
- Locate control arm index mark. This may take the form of a hole, dimple, tab, notch or arrow. **See Figure 2.**
- Do not contact ball joint backing plate during press-in.
- Ball joint index mark must align with control arm side index mark during installation. **See Figure 3.**

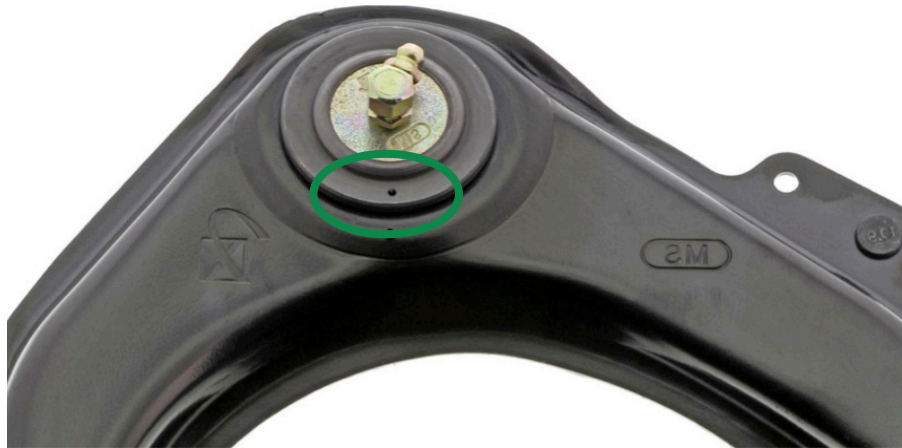
Figure 2. Control arm index mark. In this example, the index mark is a hole.

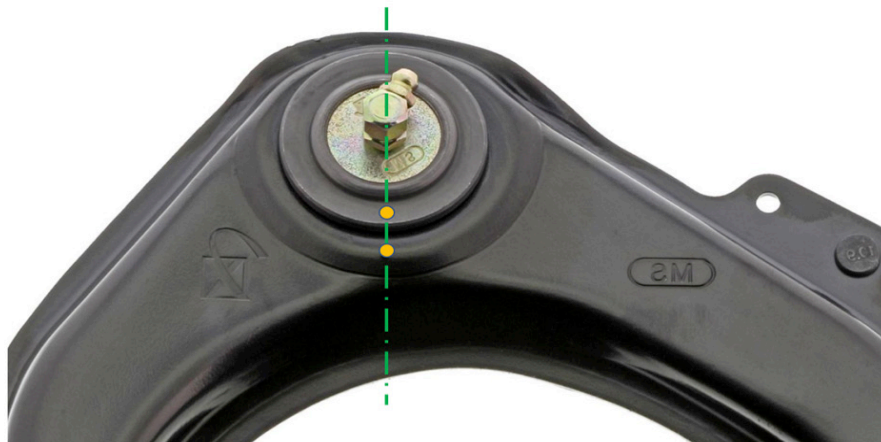
The identified part numbers are directional type ball joints; wherein they are designed to allow for an increased swing angle in a particular direction. Incorrect installation orientation of directional type ball joints may permit over travel of the ball stud in the improper direction, resulting in contact with the ball joint housing.

Figure 3. Correct installation orientation is achieved when ball joint index mark aligns with control arm side index mark.
