## Correct Installation Orientation: 2015-2011 Dodge Durango and Jeep Grand Cherokee Front Upper Ball Joint

<b>Brand</b>	Supreme	<b>Product</b>	Ball Joint	<b>Date</b>	July 2022
<b>Part Number(s)</b>	MS25551

**Part Number:**  
MS25518

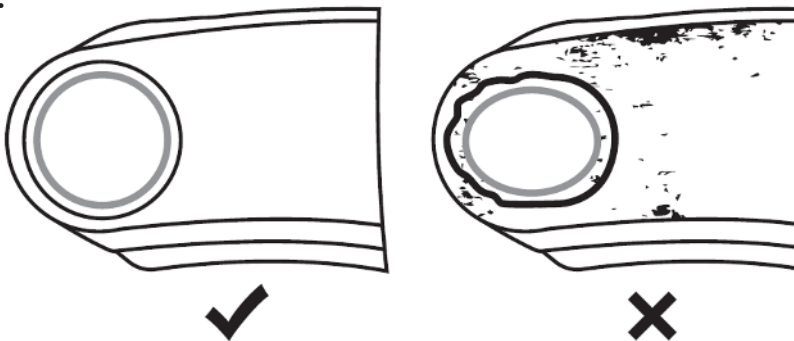
**Figure 1.**

- Before installation of ball joint, ensure all mating surfaces are clear of rust, debris and burrs. Inspect control arm mounting flange for cracks, deformation and or an out of round condition. Do not reuse control arm body if these are found. **See Figure 1.**

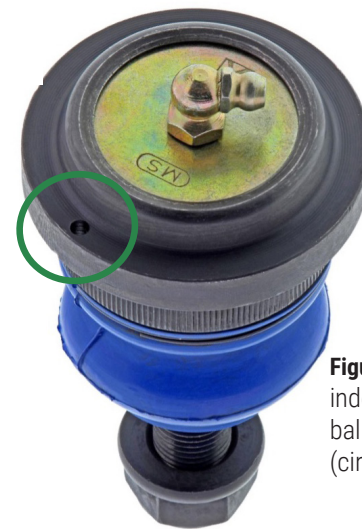
**Figure 2.** Drilled index mark on ball joint flange (circled)

- Verify press-in diameters and stud tolerances, including on steering knuckle side. Replace all damaged or out-of-specification mating components.
- When pressing-in ball joint, ensure pressure is applied to the mounting flange and not the ball joint back plate. Contact with the back plate during install may lead to damage and or impaired performance of the ball joint.
- Locate drilled index mark on ball joint flange. **See Figure 2.**

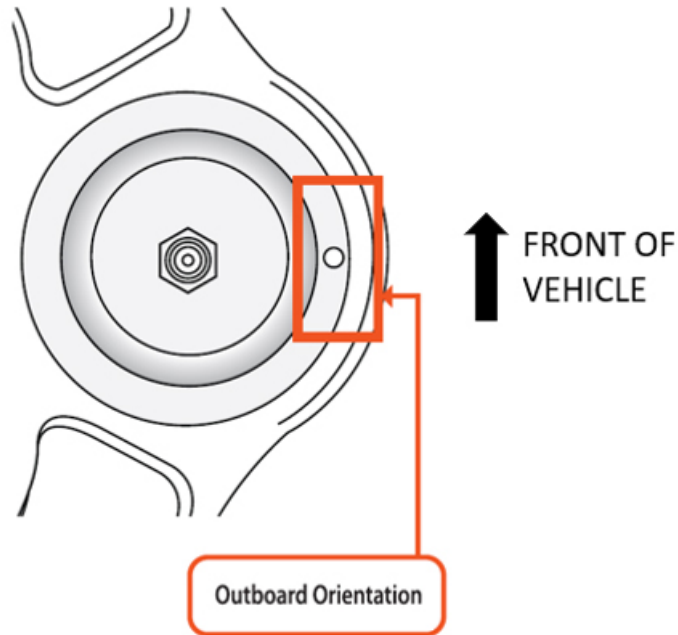
**Figure 3.** Correct ball joint installation orientation when mated to front upper control arm. Note drilled index mark position (highlighted orange box)

- During press-in, index mark must be oriented so that it is perpendicular to the wheel (facing outboard). For an illustration of correct installation orientation, **see Figure 3**.
