## Correct Installation Orientation: 2019-2011 GM 2500 HD and 3500 HD Truck Front Lower Ball Joint

<b>Brand</b>	Supreme	<b>Product</b>	Ball Joint	<b>Date</b>	October 2022
<b>Part Number(s)</b>	MS50553

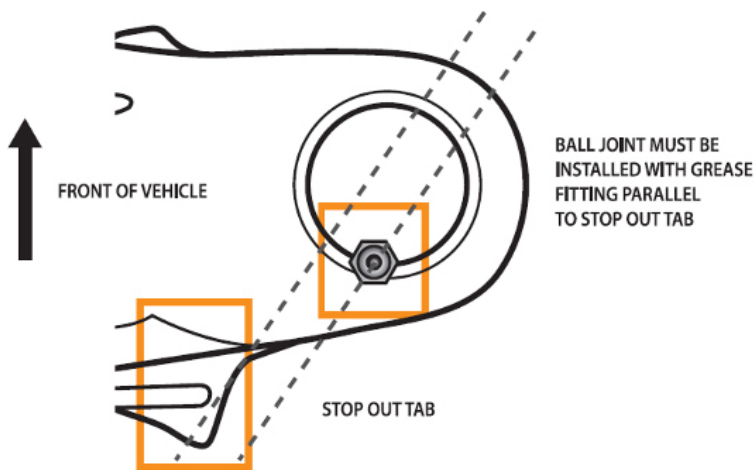
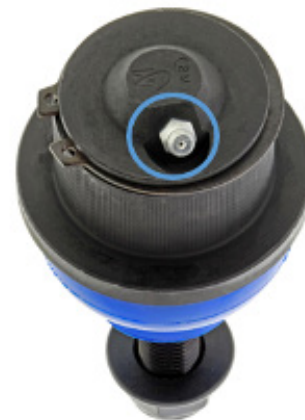
To ensure adequate access to the grease fitting, the below noted ball joint must be pressed-in using the correct orientation.

**Figure 1.** To ensure adequate clearance between components and accessibility for future relubrication service, ball joint must be installed with grease fitting parallel to front lower control arm stop out tab

- Before installation of ball joint, ensure all mating surfaces are clear of rust, debris and burrs.
- Verify press-in diameters and stud tolerances, including on steering knuckle side. Inspect mating surfaces for cracks, deformation and or an out of round condition. Replace all damaged or out-of-specification mating components.
- The ball joint must be installed with the grease fitting in parallel with the front lower control arm stop out tab. **See Figure 1.**
- Before press-in, it is recommended to create an index mark on both control arm and ball joint housing using a suitable implement, such as a grease pencil. This will assist in attaining correct orientation during press-in.
