## Correct Installation Orientation: 2019-2011 GM 2500 HD and 3500 HD Truck Front Lower Ball Joint

Brand	TTX	Product	Ball Joint	Date	October 2022
Part Number(s)	TXMS50553

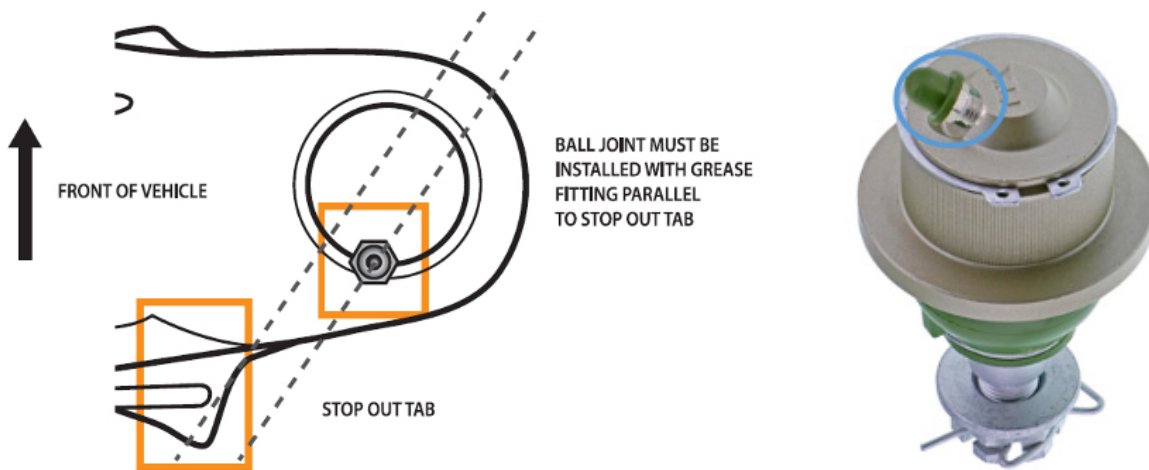
**Figure 1.** To ensure adequate clearance between components and accessibility for future relubrication service, ball joint must be installed with grease fitting parallel to front lower control arm stop out tab

To ensure adequate access to the grease fitting, the below noted ball joint must be pressed-in using the correct orientation.

- Before installation of ball joint, ensure all mating surfaces are clear of rust, debris and burrs.
- Verify press-in diameters and stud tolerances, including on steering knuckle side. Inspect mating surfaces for cracks, deformation and or an out of round condition. Replace all damaged or out-of-specification mating components.
- The ball joint must be installed with the grease fitting in parallel with the front lower control arm stop out tab. **See Figure 1.**
- Before press-in, it is recommended to create an index mark on on both control arm and ball joint housing using a suitable implement, such as a grease pencil. This will assist in attaining correct orientation during press-in.
