## Correct Installation Orientation: 2019-2014 GM 1500 Truck and SUV Front Lower Ball Joint

<b>Brand</b>	TTX	<b>Product</b>	Ball Joint	<b>Date</b>	March 2023
<b>Part Number(s)</b>	TXMS50532

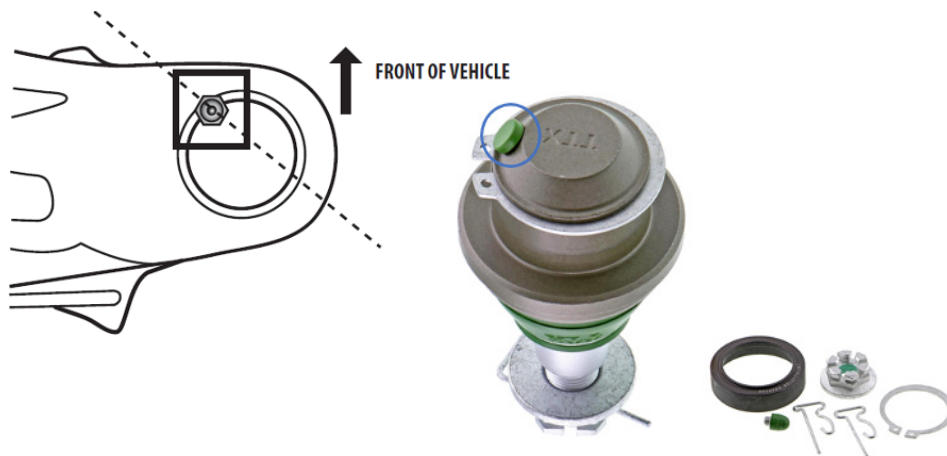
To ensure adequate access to the grease fitting for relubrication service, the below noted ball joint must be pressed-in using the correct orientation.

**Figure 1.** To ensure adequate clearance between components for relubrication service, ball joint must be installed with grease fitting positioned approximately 45° towards centerline of vehicle.

- Before installation of ball joint, ensure all mating surfaces are clear of rust, debris and burrs.
- Verify press-in diameters and stud tolerances, including on steering knuckle side. Inspect mating surfaces for cracks, deformation and or an out of round condition. Replace all damaged or out-of-specification mating components.
- Correct orientation is achieved when grease fitting is located approximately 45° towards centerline of vehicle. Grease fitting must also be positioned towards front of vehicle. **See Figure 1.**
- Before press-in, it is recommended to create an index mark on both control arm and ball joint housing using a suitable implement, such as a grease pencil. This will assist in attaining correct orientation during press-in.
