## Correct Installation Orientation: 2019-2014 GM 1500 Truck & SUV Front Lower Ball Joint

<b>Brand</b>	Supreme	<b>Product</b>	Ball Joint	<b>Date</b>	March 2023
<b>Part Number(s)</b>	MS50532

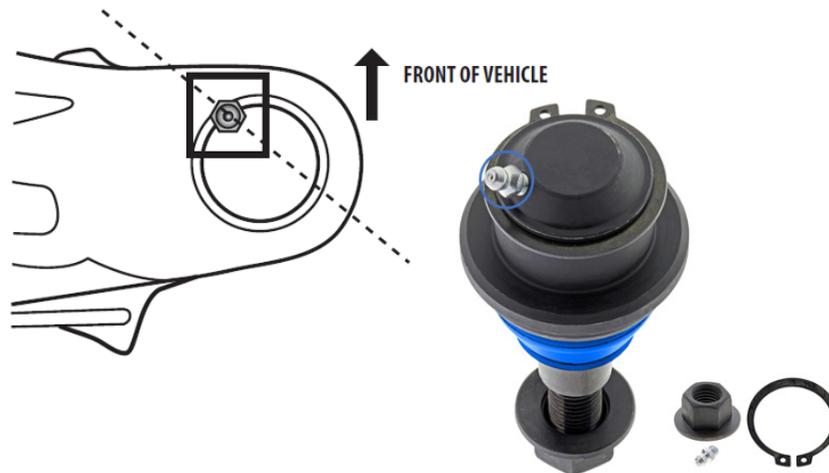
**Figure 1.** To ensure adequate clearance between components for relubrication service, ball joint must be installed with grease fitting positioned approximately 45° towards centerline of vehicle.

- Before installation of ball joint, ensure all mating surfaces are clear of rust, debris and burrs.
- Verify press-in diameters and stud tolerances, including on steering knuckle side. Inspect mating surfaces for cracks, deformation and or an out of round condition. Replace all damaged or out-of-specification mating components.
- Correct orientation is achieved when grease fitting is located approximately 45° towards centerline of vehicle. Grease fitting must also be positioned towards front of vehicle. **See Figure 1.**
- Before press-in, it is recommended to create an index mark on both control arm and ball joint housing using a suitable implement, such as a grease pencil. This will assist in attaining correct orientation during press-in.
