Correct Installation Orientation: 2019-2015 GM 1500 Truck and SUV Front Upper Ball Joint

Brand	TTX	Product	Ball Joint	Date	September 2021
Part Number(s)	TXMS50575

Part Number:
TXMS50575

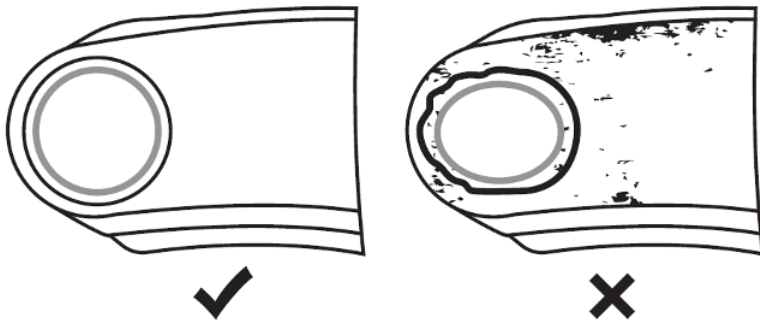
Figure 1.

- Before installation of ball joint, ensure all mating surfaces are clear of rust, debris and burrs. Inspect control arm mounting flange for cracks, deformation and/or an out-of-round condition. Do not reuse control arm body if these are found. **See Figure 1.**

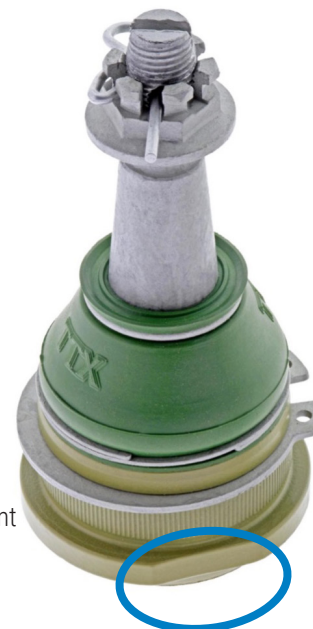
Figure 2.
Machined flat on ball joint housing (circled)

- Verify press in diameters and stud tolerances, including steering knuckle. Replace all damaged or out-of-specification mating components.
- When pressing in ball joint, ensure pressure is applied to the mounting flange and not the ball joint back plate. Contact with the back plate during installation may lead to damage and/or compromised performance of the ball joint.
- Locate machined flat on ball joint housing. **See Figure 2.**

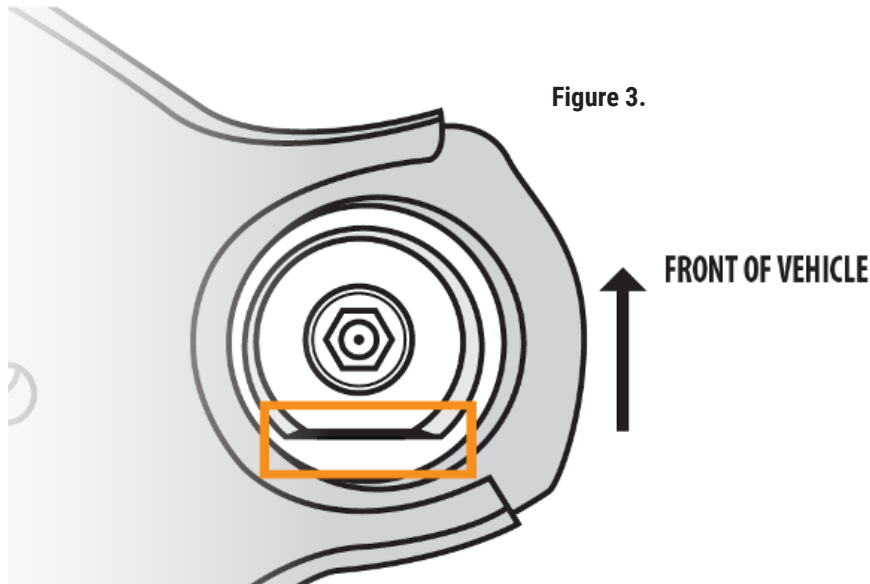
Figure 3. Correct ball joint installation orientation when mated to OEM stamped steel front upper control arm. Note machined flat position (highlighted orange box).

- During press in, flat must be oriented so that it is perpendicular to the wheel. For an illustration of correct installation orientation, see **Figure 3**.
