## Correct Installation Orientation: 2019-2015 GM 1500 Truck & SUV Front Upper Ball Joint

<b>Brand</b>	Supreme	<b>Product</b>	Ball Joint	<b>Date</b>	July 2022
<b>Part Number(s)</b>	MS50575

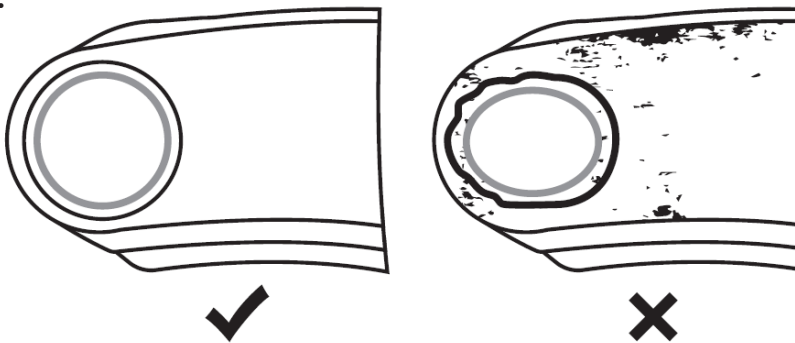
**Figure 1.**

- Before installation of ball joint, ensure all mating surfaces are clear of rust, debris and burrs. Inspect control arm mounting flange for cracks, deformation and or an out of round condition. Do not reuse control arm body if these are found. **See Figure 1.**

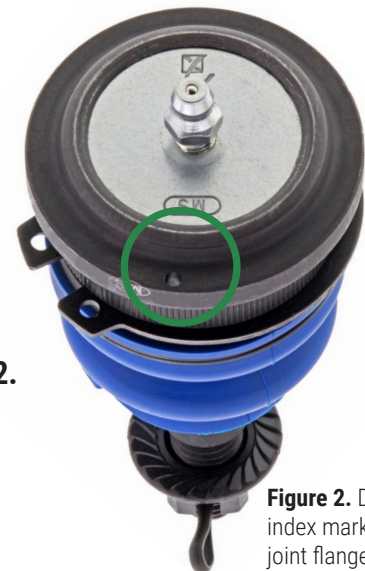
**Figure 2.** Drilled index mark on ball joint flange (circled)

- Verify press-in diameters and stud tolerances, including on steering knuckle side. Replace all damaged or out-of-specification mating components.
- When pressing-in ball joint, ensure pressure is applied to the mounting flange and not the ball joint back plate. Contact with the back plate during install may lead to damage and or impaired performance of the ball joint.
- Locate drilled index mark on ball joint flange. **See Figure 2.**

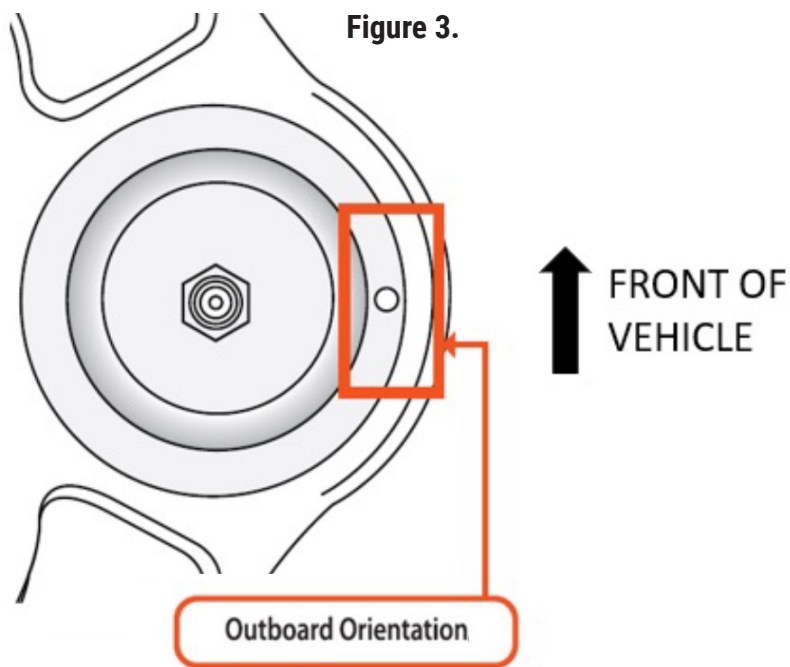
**Figure 3.** Correct ball joint installation orientation when mated to OEM stamped steel front upper control arm. Note drilled index mark position (highlighted orange box)

- During press-in, index mark must be oriented so that it is perpendicular to the wheel (facing outboard). For an illustration of correct installation orientation, **see Figure 3.**
