Correct Installation Orientation: 2021-1999 GM 2500-3500-4500 Van Front Upper Ball Joint

Brand	TTX	Product	Ball Joint	Date	March 2023
Part Number(s)	TXK6694

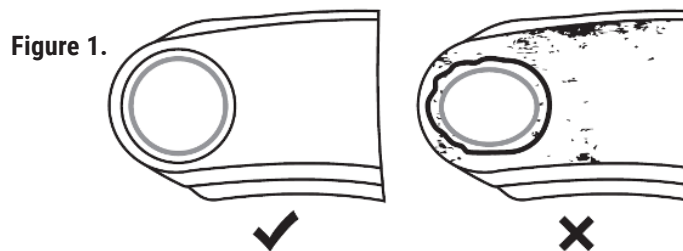
- Before installation of ball joint, ensure all mating surfaces are clear of rust, debris and burrs. Inspect control arm mounting flange for cracks, deformation and or an out of round condition. Do not reuse control arm body if these are found. **See Figure 1.**

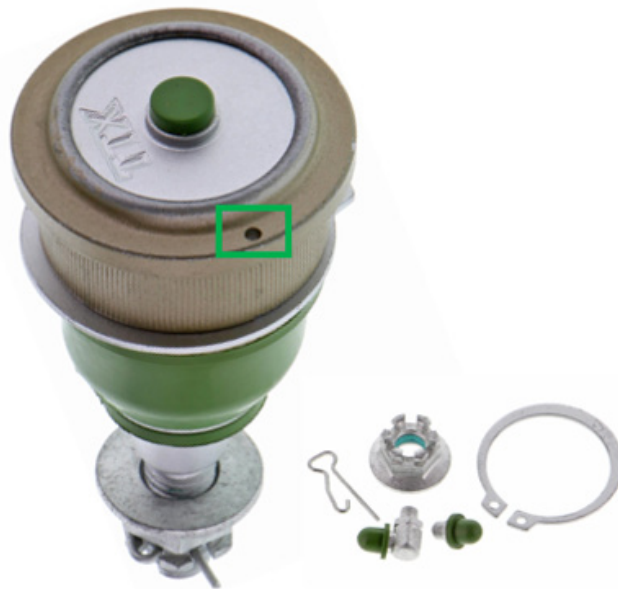
Figure 2. Drilled index mark on ball joint flange (callout box)

- Verify press-in diameters and stud tolerances, including on steering knuckle side. Replace all damaged or out-of-specification mating components.
- When pressing-in ball joint, ensure pressure is applied to the mounting flange and not the ball joint back plate. Contact with the back plate during install may lead to damage and or impaired performance of the ball joint.
- Locate drilled index mark on ball joint flange. **See Figure 2.**
- Before press-in, it is recommended to create an alignment mark on both control arm and ball joint housing using a suitable implement, such as a grease pencil. This will assist in attaining correct orientation during press-in.

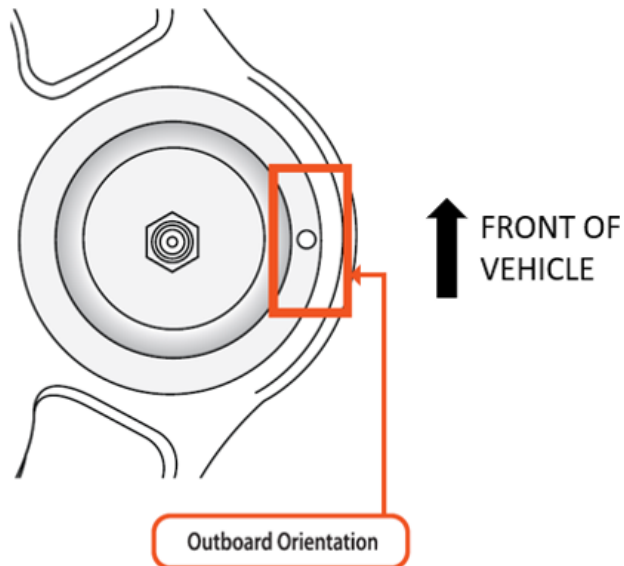
Figure 3. Correct ball joint installation orientation when mated to front upper control arm. Note drilled index mark position (highlighted orange box)

- During press-in, index mark must be oriented so that it is perpendicular to the wheel (facing outboard). For an illustration of correct installation orientation, **see Figure 3.**
