Correct Installation Orientation: 2021-1999 GM 2500-3500-4500 Van Front Upper Ball Joint

Brand	Supreme	Product	Ball Joint	Date	March 2023
Part Number(s)	MK6694

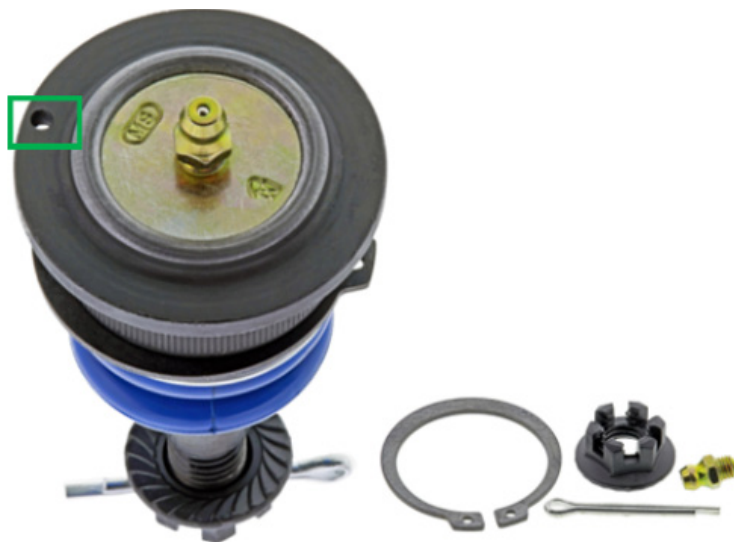
Figure 2. Drilled index mark on ball joint flange (callout box)

- Verify press-in diameters and stud tolerances, including on steering knuckle side. Replace all damaged or out-of-specification mating components.
- When pressing-in ball joint, ensure pressure is applied to the mounting flange and not the ball joint back plate. Contact with the back plate during install may lead to damage and or impaired performance of the ball joint.
- Locate drilled index mark on ball joint flange. **See Figure 2.**
- Before press-in, it is recommended to create an alignment mark on both control arm and ball joint housing using a suitable implement, such as a grease pencil. This will assist in attaining correct orientation during press-in.

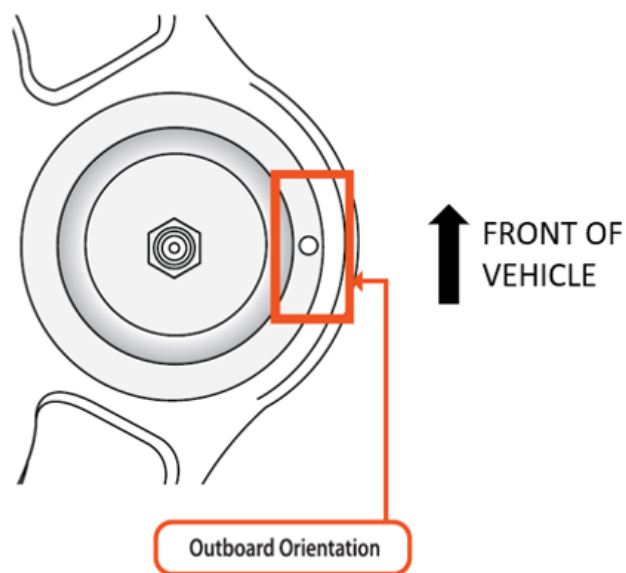
Figure 3. Correct ball joint installation orientation when mated to front upper control arm. Note drilled index mark position (highlighted orange box)

- During press-in, index mark must be oriented so that it is perpendicular to the wheel (facing outboard). For an illustration of correct installation orientation, **see Figure 3.**
