Correct Installation Orientation: 2022-2014 RAM 2500 & 3500 Front Lower Ball Joint

| Brand | Supreme | Product | Ball Joint | Date | September 2022 |
| Part Number(s) | MS25532 | | | | |

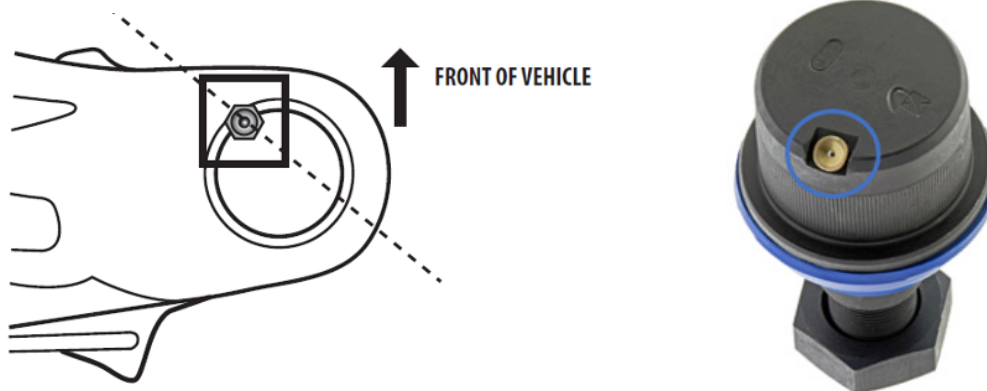
To ensure adequate access to the grease fitting for relubrication service, the below noted ball joint must be pressed-in using the correct orientation.

Figure 1. To ensure adequate clearance between components for relubrication service, ball joint must be installed with grease fitting positioned approximately 45° towards centerline of vehicle.

- Before installation of ball joint, ensure all mating surfaces are clear of rust, debris and burrs.
- Verify press-in diameters and stud tolerances, including on steering knuckle side. Inspect mating surfaces for cracks, deformation and or an out of round condition. Replace all damaged or out-of-specification mating components.
- Correct orientation is achieved when grease fitting is located approximately 45° towards centerline of vehicle. Grease fitting must also be positioned towards front of vehicle. **See Figure 1.**
- Before press-in, it is recommended to create an index mark on both axle and ball joint housing using a suitable implement, such as a grease pencil. This will assist in attaining correct orientation during press-in.
