Correct Installation Orientation: 2022-2014 RAM 2500 and 3500 Front Lower Ball Joint

Brand	TTX	Product	Ball Joint	Date	September 2022
Part Number(s)	TXMS25532

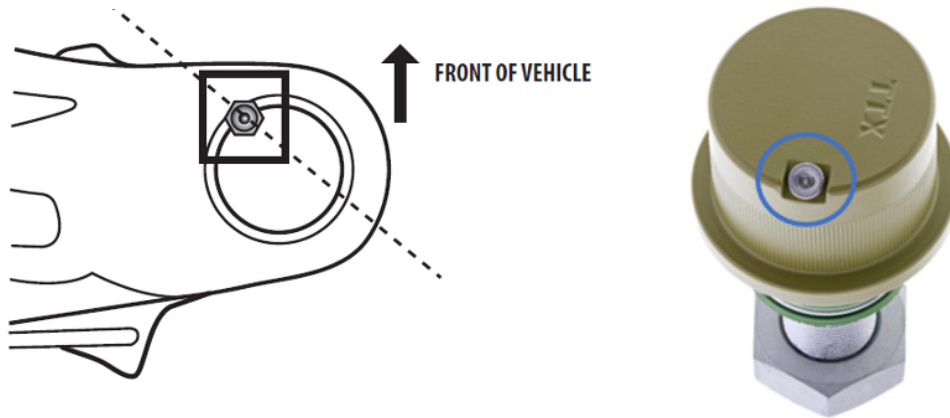
To ensure adequate access to the grease fitting for relubrication service, the below noted ball joint must be pressed-in using the correct orientation.

Figure 1. To ensure adequate clearance between components for relubrication service, ball joint must be installed with grease fitting positioned approximately 45° towards centerline of vehicle.

- Before installation of ball joint, ensure all mating surfaces are clear of rust, debris and burrs.
- Verify press-in diameters and stud tolerances, including on steering knuckle side. Inspect mating surfaces for cracks, deformation and or an out of round condition. Replace all damaged or out-of-specification mating components.
- Correct orientation is achieved when grease fitting is located approximately 45° towards centerline of vehicle. Grease fitting must also be positioned towards front of vehicle. **See Figure 1.**
- Before press-in, it is recommended to create an index mark on both axle and ball joint housing using a suitable implement, such as a grease pencil. This will assist in attaining correct orientation during press-in.
