Correct Installation Orientation: Ford F-150, Ford Expedition and Lincoln Navigator Front Upper Ball Joint

Brand	Supreme	Product	Ball Joint	Date	October 2022
Part Number(s)	MK80014

Part Number:
MK80014

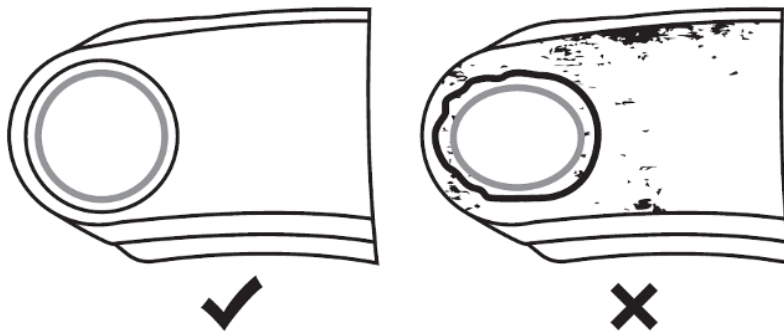
Figure 1.

- Before installation of ball joint, ensure all mating surfaces are clear of rust, debris and burrs. Inspect control arm mounting flange for cracks, deformation and or an out of round condition. Do not reuse control arm body if these are found. **See Figure 1.**

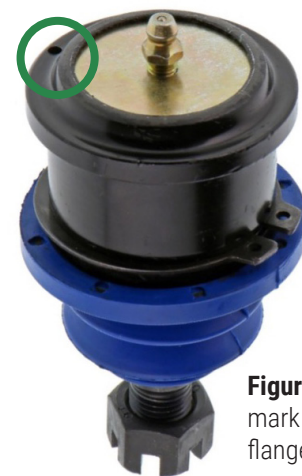
Figure 2. Drilled index mark on ball joint flange (circled)

- Verify press-in diameters and stud tolerances, including on steering knuckle side. Replace all damaged or out-of-specification mating components.
- When pressing-in ball joint, ensure pressure is applied to the mounting flange and not the ball joint back plate. Contact with the back plate during install may lead to damage and or impaired performance of the ball joint.
- Locate drilled index mark on ball joint flange. **See Figure 2.**

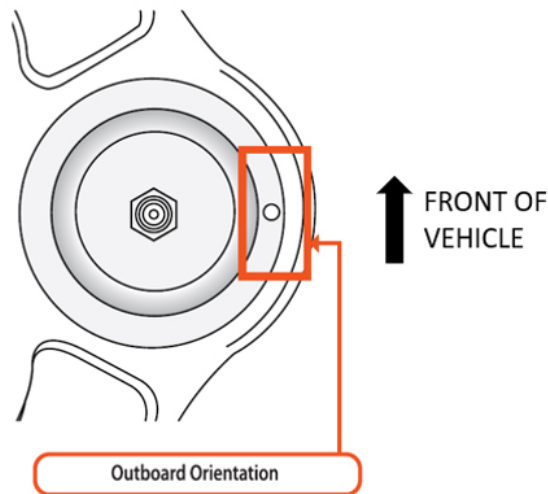
Figure 3. Correct ball joint installation orientation when mated to front upper control arm. Note drilled index mark position (highlighted orange box)

- During press-in, index mark must be oriented so that it is perpendicular to the wheel (facing outboard). For an illustration of correct installation orientation, **see Figure 3.**
