Correct Installation Orientation: Ford F-150, Ford Expedition & Lincoln Navigator Front Upper Ball Joint

Brand	TTX	Product	Ball Joint	Date	October 2022
Part Number(s)	TXK80014

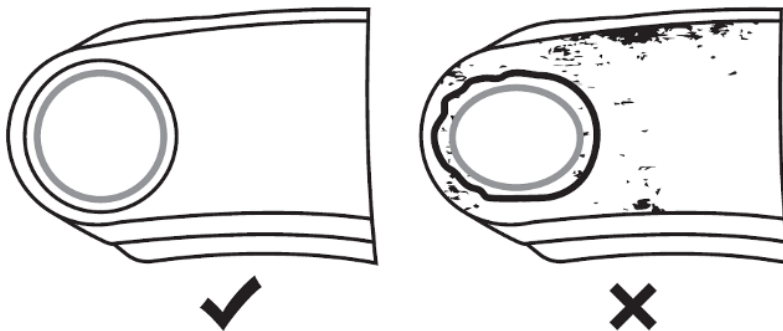
Figure 1.

- Before installation of ball joint, ensure all mating surfaces are clear of rust, debris and burrs. Inspect control arm mounting flange for cracks, deformation and or an out of round condition. Do not reuse control arm body if these are found. **See Figure 1.**

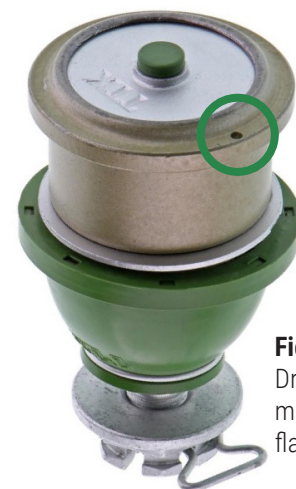
Figure 2.
Drilled index mark on ball joint flange (circled)

- Verify press-in diameters and stud tolerances, including on steering knuckle side. Replace all damaged or out-of-specification mating components.
- When pressing-in ball joint, ensure pressure is applied to the mounting flange and not the ball joint back plate. Contact with the back plate during install may lead to damage and or impaired performance of the ball joint.
 - Locate drilled index mark on ball joint flange. **See Figure 2.**

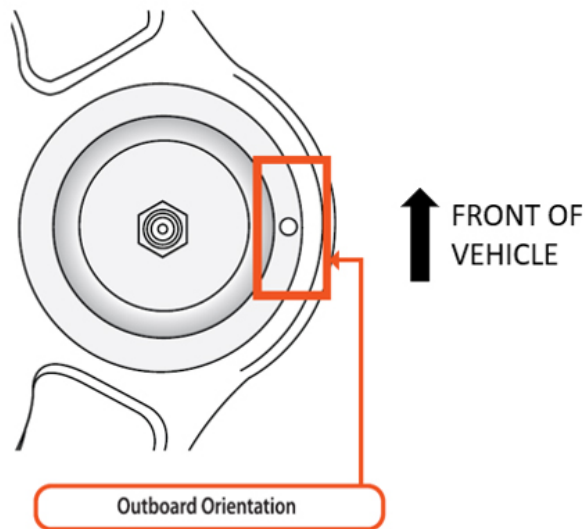
Figure 3. Correct ball joint installation orientation when mated to front upper control arm. Note drilled index mark position (highlighted orange box)

- During press-in, index mark must be oriented so that it is perpendicular to the wheel (facing outboard). For an illustration of correct installation orientation, **see Figure 3**.
