Correct Installation Orientation: Ford Ranger, Ford Explorer and Mazda B-Series Front Upper Ball Joint

Brand	Supreme	Product	Ball Joint	Date	September 2022
Part Number(s)	MK80012

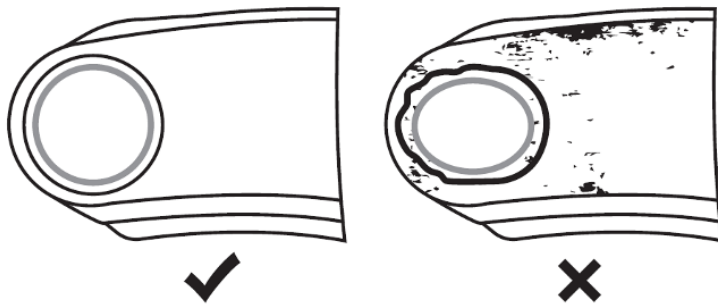
Figure 1.

- Before installation of ball joint, ensure all mating surfaces are clear of rust, debris and burrs. Inspect control arm mounting flange for cracks, deformation and or an out of round condition. Do not reuse control arm body if these are found. **See Figure 1.**

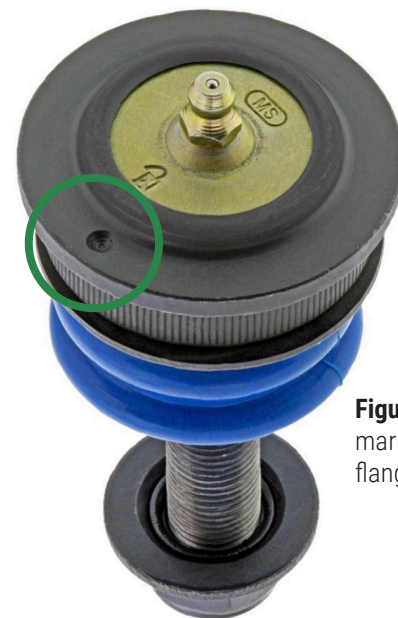
Figure 2. Drilled index mark on ball joint flange (circled)

- Verify press-in diameters and stud tolerances, including on steering knuckle side. Replace all damaged or out-of-specification mating components.
- When pressing-in ball joint, ensure pressure is applied to the mounting flange and not the ball joint back plate. Contact with the back plate during install may lead to damage and or impaired performance of the ball joint.
- Locate drilled index mark on ball joint flange. **See Figure 2.**

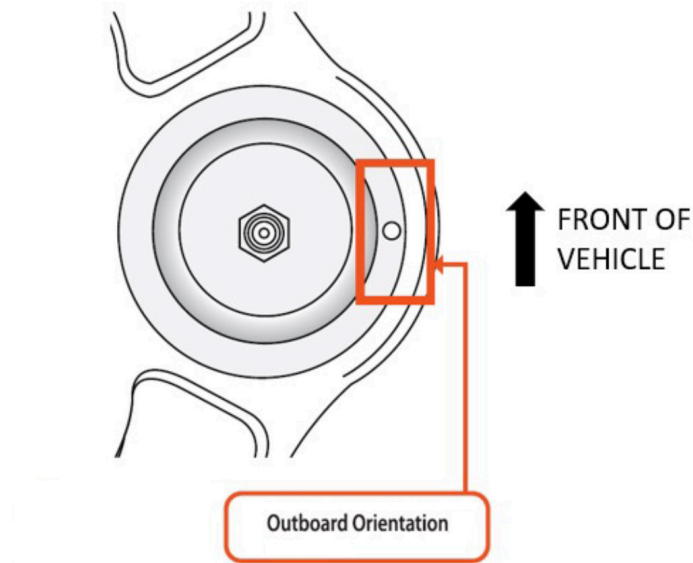
Figure 3. Correct ball joint installation orientation when mated to front upper control arm. Note drilled index mark position (highlighted orange box)

- During press-in, index mark must be oriented so that it is perpendicular to the wheel (facing outboard). For an illustration of correct installation orientation, **see Figure 3.**
