Nissan and Infiniti Control Arm Ball Joint Seating Cone

Brand	Original Grade/Supreme	Product	Control Arms	Date	August 2021
Part Number(s)	Various

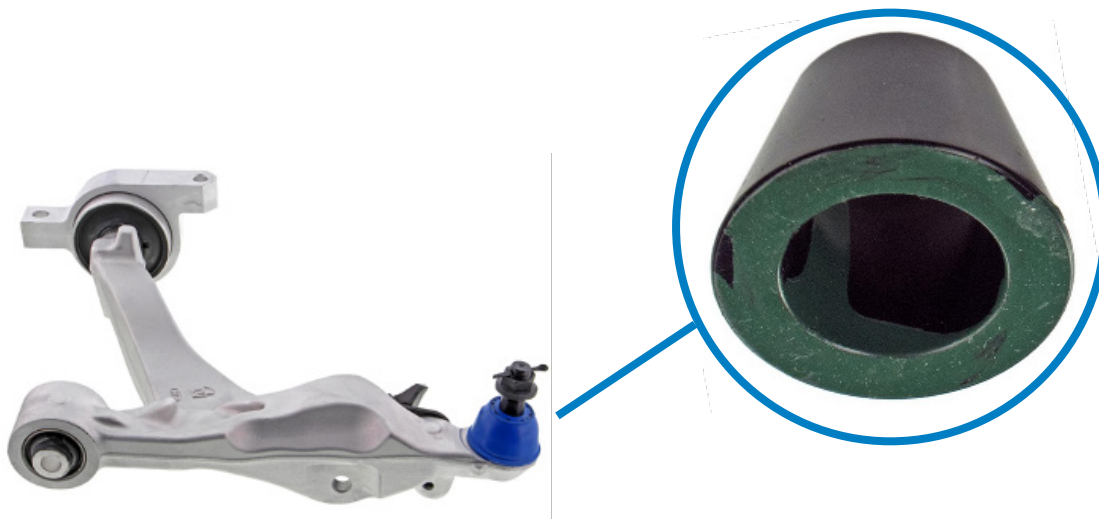
Occasionally, when removing the original part from the steering knuckle, the ball joint seating cone will become seized to the ball joint stud. Essentially, instead of remaining positioned in the steering knuckle bore when the control arm is removed, the cone will be extracted along with the ball joint. This will lead to the above-mentioned visual discrepancy. **See Figure 1.**

Figure 1. Typical Nissan and Infiniti ball joint seating cone (circled). This cone may become seized to the ball joint stud and cause a visual discrepancy when compared to the new replacement control arm.

It is important to adhere to the factory service manual for all removal procedures when separating a ball joint from a steering knuckle or control arm that uses a cone. Often, a special tool will be required or specified to retain the cone in the bore as the ball joint is removed.

If the cone must be removed from the ball joint stud for reuse, it must be separated carefully. A combination of penetrating oil and a three-jaw puller will usually suffice. All rust and corrosion must be cleaned from both the cone and steering knuckle or control arm bore. Additionally, the cone and mating component must be inspected for any damage and/or an 'out-of-round' condition. Do not reuse the cone or mating component if signs of damage or abnormal wear are found during inspection.
