Seized Steering Knuckle Insert on Ford Fusion, Lincoln MKX and Mercury Milan Front Lower Forward Control Arms

Brand	Supreme/OG	Product	Control Arms	Date	October 2020
Part Number(s)	CMS40181/GS40181

Issue: Seized Steering Knuckle Insert

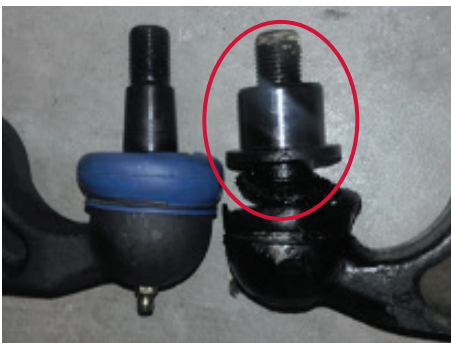
When removing the original control arm for replacement, the steering knuckle insert may become seized to the ball joint stud.

This will cause the replacement arm to look different in appearance. See Figure 1.

Figure 1: Seized insert (circled) on original control arm stud

If the insert is seized to the ball joint stud, it must be carefully removed and re-inserted into the steering knuckle. Do not use a hammer or apply blunt force to aid in removal or installation. This can warp/distort or otherwise damage the insert.

Ensure to remove all rust, burrs and other contaminants from the insert and knuckle bore. Inspect the bore and insert abnormal wear, enlargement, "out of roundness" and or other damage before installation.

Ensure all components are torqued to the correct values as specified in factory service manual. After repair, perform vehicle alignment.
