VW MK4 Golf, Jetta and New Beetle – Axle Beam and Trailing Arm Bushing

Brand	Supreme	Product	Bushing	Date	June 2020
Part Number(s)	MS70406

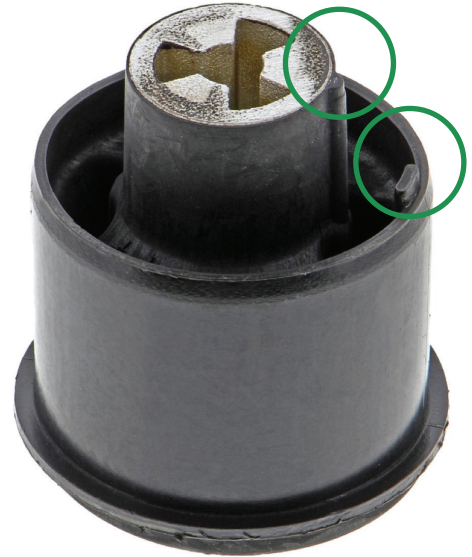
Figure 1: Tab indicator

- Ensure correct orientation and direction of axle beam bushing during install. Generally, this will mean locating the clocking indicator (this may be a notch, arrow or tab) on the bushing face or sleeve and aligning it to the edge of the trailing arm. (Figure 1)
