Issue: Ball Joint Replacement and Memory Steer on 4WD Dana 60 Axle Equipped Trucks

Publication:	TSB-20-017-01-01-E	Product	Ball Joints	Date	April 2020
Part Number(s)	Original Grade: GK80026, GK8607T Supreme:MK80026, MK8607T, MS40056 TTX: TXK80026, TXK8607T

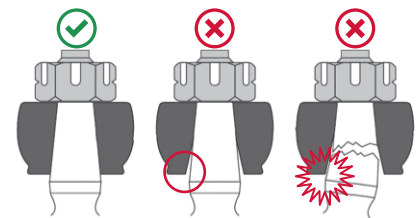
Figure 1

1. Ensure to check press-in diameters and tapered hole/stud tolerances. Replace all damaged or out of specification mating components.
 - If a broken, bent or loose ball joint stud is discovered, the knuckle must be replaced. If there is deformation, an out-of-round condition or damage to the tapered mating surfaces of the steering knuckle, it must be replaced (Figure 1).
