Correct Installation Procedure for 2007-2012 Dodge Caliber & 2007-2016 Jeep Compass and Patriot Front Lower Ball Joint

Brand	Supreme	Product	Ball Joint	Date	August 2020
Part Number(s)	MS25511

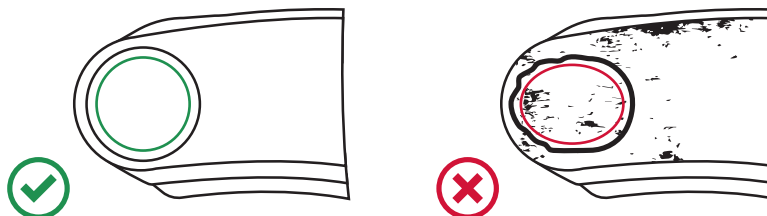
Figure 2

- A (46MM) or (1-13/16") socket is required.
- Ensure all mating surfaces are clear of rust, debris and burrs. Inspect control arm mounting flange for cracks, deformation and or an out of round condition. Do not reuse control arm body if these are found. **(See Figure 2)**

Ensure to check press-in diameters and stud tolerances. Replace all damaged or out of specification mating components.

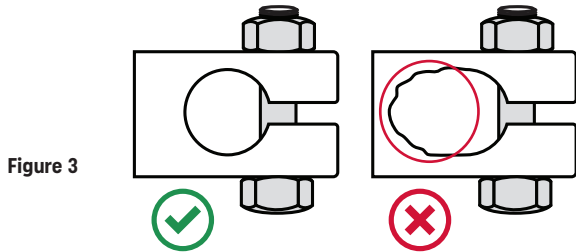
If a broken, bent or loose ball joint stud is discovered, the steering knuckle must be replaced. Inspect knuckle ear for abnormal wear, enlargement, "out of roundness" and or other damage. Replace knuckle if these are found. (See Figure 3)

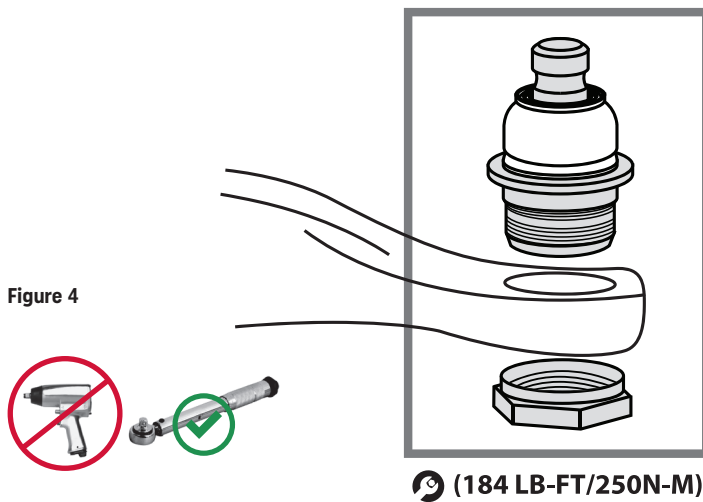
Ball joint retention nut must be tightened to **(184 LB-FT/250N-M)**. (See Figure 4)

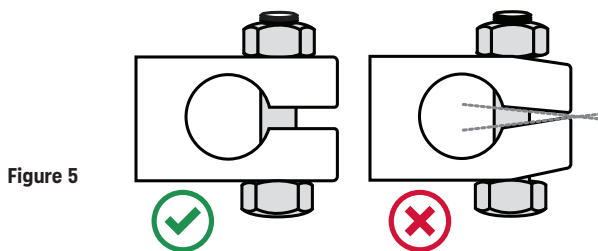
Do not overtighten pinch bolt and nut. This may cause damage to the knuckle ear. Follow torque value and or sequence as found in the factory service manual. (See Figure 5)
