Correct Installation Orientation: 2020-2015 GM 1500 Truck & SUV Front Lower Ball Joint

Brand	TTX	Product	Ball Joint	Date	September 2020
Part Number(s)	TXMS50580

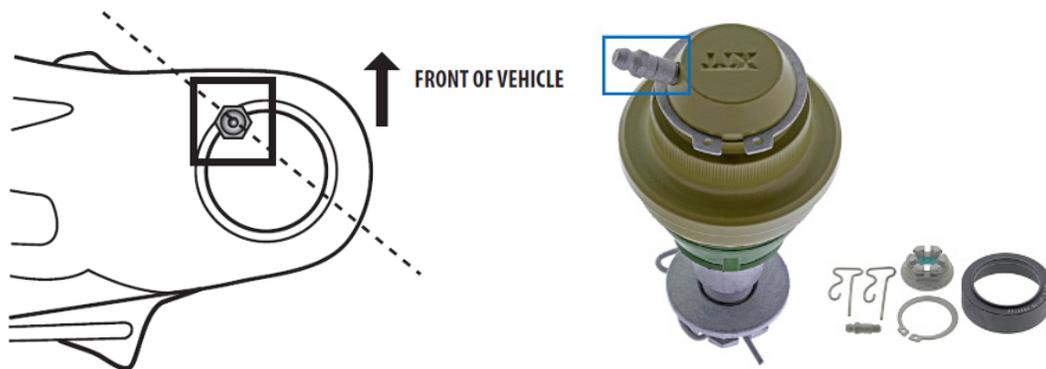
Figure 1. To ensure adequate clearance between components for relubrication service, ball joint must be installed with grease fitting positioned approximately 45° towards centerline of vehicle. Grease fitting must also be positioned facing front of vehicle.

- Before installation of ball joint, ensure all mating surfaces are clear of rust, debris and burrs.
- Verify press-in diameters and stud tolerances, including on steering knuckle side. Inspect mating surfaces for cracks, deformation and or an out of round condition. Replace all damaged or out-of-specification mating components.
- Correct orientation is achieved when grease fitting is located approximately 45° towards centerline of vehicle. Grease fitting must also be positioned towards front of vehicle. **See Figure 1.**
- Before press-in, it is recommended to create an index mark on both control arm and ball joint housing using a suitable implement, such as a grease pencil. This will assist in attaining correct orientation during press-in.
