Issue: Correct Installation Orientation to Ensure Access for Relubrication Service

Brand	TTX	Product	Ball Joint	Date	June 2021
Part Number(s)	TXK9513

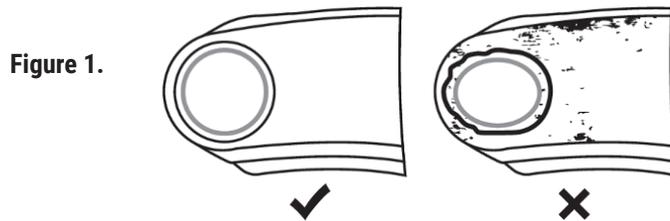
Ensure all mating surfaces are clear of rust, debris and burrs. Inspect control arm mounting flange for cracks, deformation and or an out of round condition. Do not reuse control arm body if these are found. **See Figure 1.**

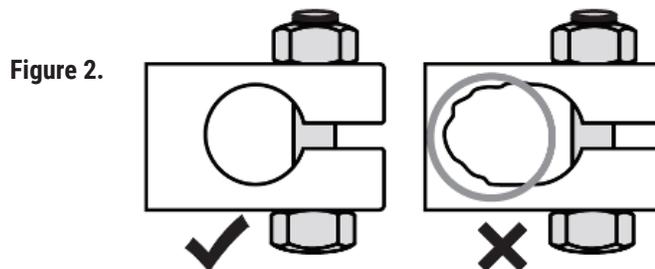
Ensure to check press-in diameters and stud tolerances. Replace all damaged or out of specification mating components. Inspect knuckle ear for abnormal wear, enlargement, "out of roundness" and or other damage. Replace knuckle if these are found. **See Figure 2.**

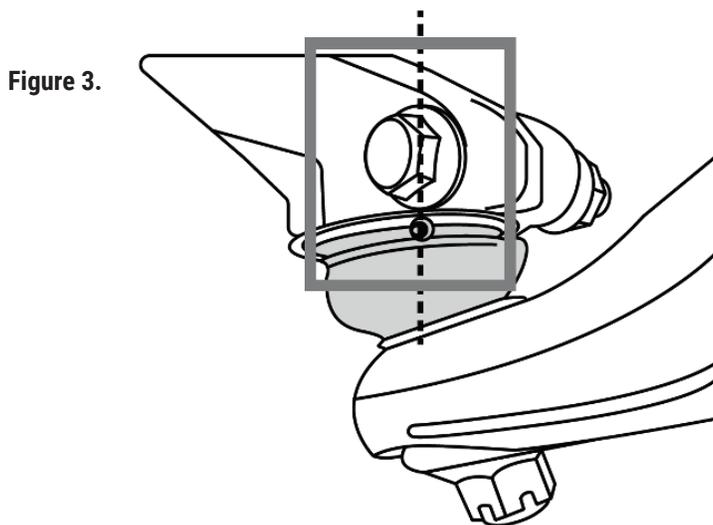
It is recommended to install this ball joint with the steering knuckle in the straight-ahead position and to orient the grease fitting approximately in line with the head of the pinch bolt. This will provide sufficient clearance for relubrication. **See Figure 3.**

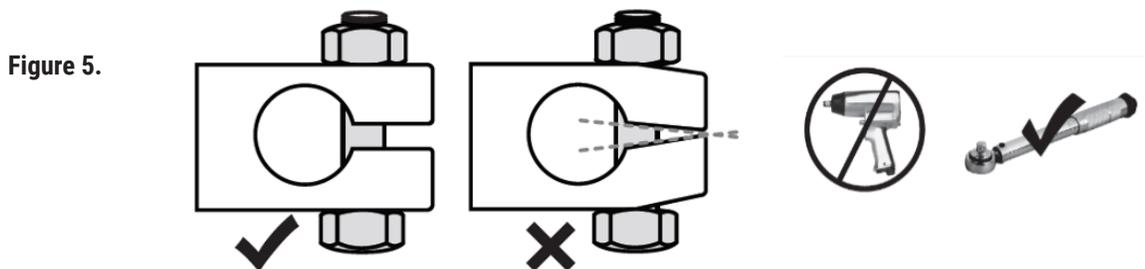
Do not overtighten pinch bolt. This may cause damage to the knuckle ear. **See Figure 5.** Follow torque value as found in factory service manual.
