### Issue: Ball Joint Replacement and Memory Steer on RWD Ford F Series and E Series

<b>Publication:</b>	TSB-20-018-01-01-E	<b>Product</b>	Ball Joints	<b>Date</b>	May 2020
<b>Part Number(s)</b>	Original Grade: GK80028, GK80197, GK80196, GK80027 Supreme: MK80028, MK80197, MK80196, MK80027, MS40060 TTX: TXK80028, TXK80197, TXK80196, TXK80027

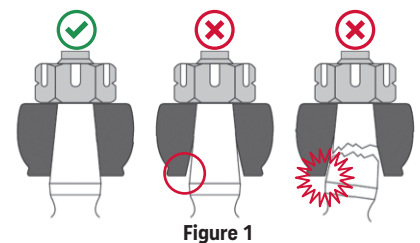
1. Ensure to check press-in diameters and tapered hole/stud tolerances. Replace all damaged or out of specification mating components.
  - If a broken, bent or loose ball joint stud is discovered, the knuckle must be replaced. If there is deformation, an out-of-round condition or damage to the tapered mating surfaces of the steering knuckle, it must be replaced (Figure 1).
