2015-2009 Honda Pilot Front Steering Knuckle Tapered Sleeve

Brand	Supreme	Product	Control Arm	Date	August 2022
Part Number(s)	CMS601043/CMS601044

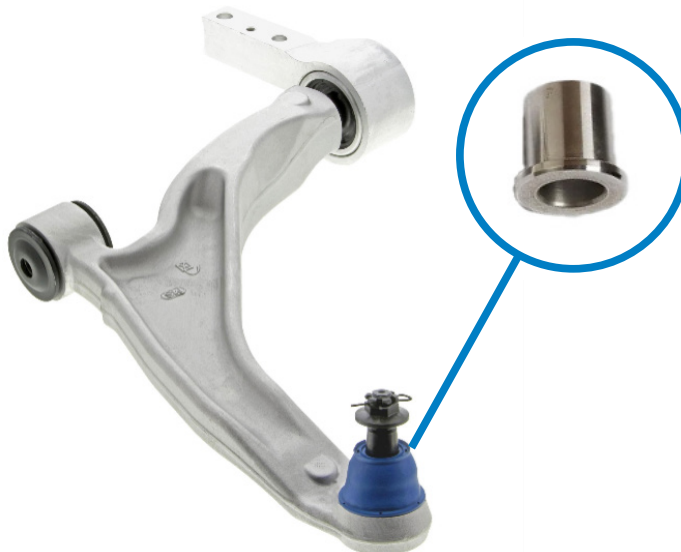
Occasionally, when removing the aluminum front lower control arm from the steering knuckle, the steering knuckle tapered sleeve will become seized to the ball joint stud. This will lead to the above-mentioned visual discrepancy. See Figure 1.

Figure 1. Steering knuckle sleeve (circled) may become seized to the ball joint stud, and when compared to the new replacement part cause a visual difference between the two. Mevotech Supreme control arm assemblies feature an anti-corrosion coated ball stud to reduce potential of seizing.

It is important to adhere to the factory service manual for all removal procedures when separating a control arm from the steering knuckle which uses a tapered sleeve. Often, a special tool will be required or specified to retain the sleeve in the knuckle bore as the ball joint portion is removed.

If the sleeve must be removed from the ball joint stud for re-use, it must be separated carefully. A combination of penetrating oil and a three-jaw puller will usually suffice. All rust and corrosion must be cleaned from the sleeve and steering knuckle bore. Additionally, the sleeve and mating component must be inspected for any damage and or an 'out-of-round' condition. Do not re-use the sleeve or mating component if signs of damage or abnormal wear are found during inspection.
