## Best Practices: Import Vehicle Rear Wheel Bearing Repair

<b>Brand</b>	Supreme	<b>Product</b>	Wheel Bearings	<b>Date</b>	September 2021
<b>Part Number(s)</b>	Various

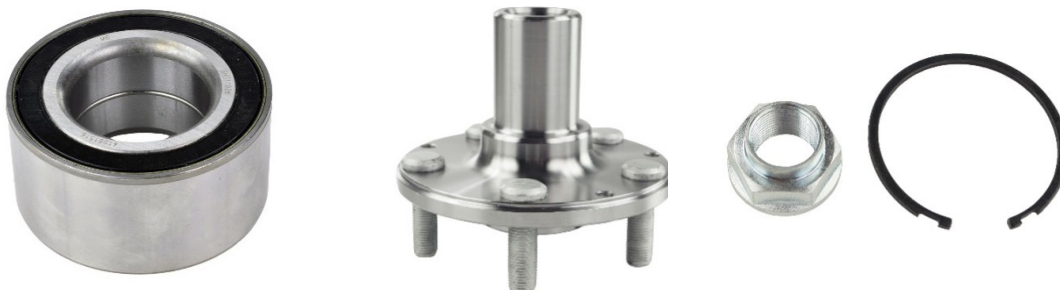
**Figure 1.** Typical Generation 1 bearing, wheel hub and hardware combination found in the rear wheel end of import vehicles.

Many import OEMs continue to use a Generation 1 bearing type pressed onto a wheel hub on the rear wheel end of a vehicle. These may be driven or non-driven axles on FWD, RWD or AWD applications.
