Correct Installation Orientation: 2010-2006 Hummer H3 Front Lower Ball Joint

Brand	Supreme	Product	Ball Joint	Date	November 2022
Part Number(s)	MS50529

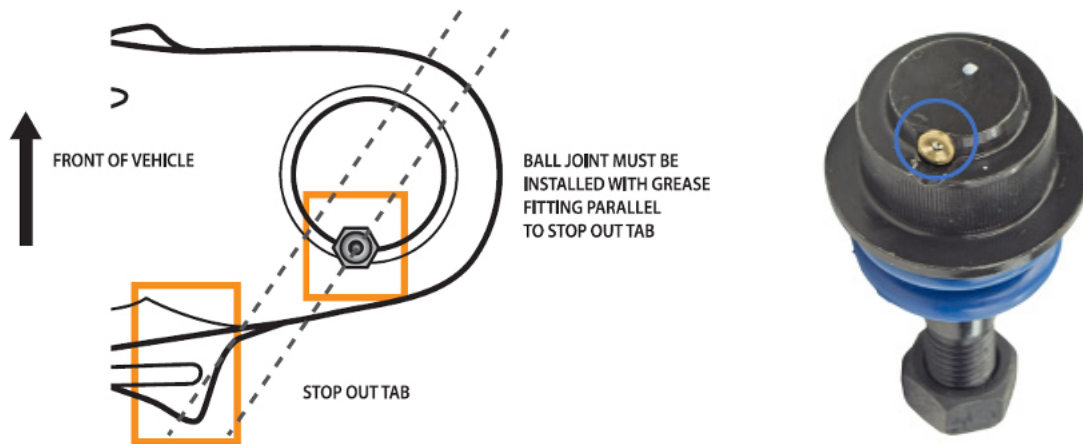
Figure 1. To ensure adequate clearance between components and accessibility for future relubrication service, ball joint must be installed with grease fitting parallel to front lower control arm stop out tab

To ensure adequate access to the grease fitting, the below noted ball joint must be pressed-in using the correct orientation.

- Before installation of ball joint, ensure all mating surfaces are clear of rust, debris and burrs.
- Verify press-in diameters and stud tolerances, including on steering knuckle side. Inspect mating surfaces for cracks, deformation and or an out of round condition. Replace all damaged or out-of-specification mating components.
- The ball joint must be installed with the grease fitting in parallel with the front lower control arm stop out tab. **See Figure 1.**
- Before press-in, it is recommended to create an index mark on both the control arm and ball joint housing using a suitable implement, such as a grease pencil. This will assist in attaining correct orientation during press-in.
