Correct Installation Orientation: 2011-2003 Ford Full-Size Sedan Front Upper Ball Joint (Stamped Steel Control Arm)

Brand	Supreme	Product	Ball Joint	Date	August 2022
Part Number(s)	MS40547

To ensure proper part performance, the below noted ball joint must be pressed-in using the correct orientation when mating to the front upper stamped steel control arm.

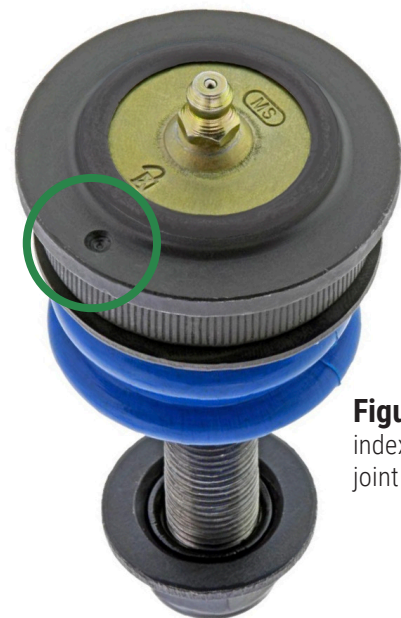
Figure 2. Drilled index mark on ball joint flange (circled)

- Verify press-in diameters and stud tolerances, including on steering knuckle side. Replace all damaged or out-of-specification mating components.
- When pressing-in ball joint, ensure pressure is applied to the mounting flange and not the ball joint back plate. Contact with the back plate during install may lead to damage and or impaired performance of the ball joint.
- Locate drilled index mark on ball joint flange. **See Figure 2.**
