## Correct Installation Orientation: 2018-2007 Jeep Wrangler JK/JKU Front Lower Ball Joint

Brand	TTX	Product	Ball Joint	Date	September 2022
Part Number(s)	TXK3185

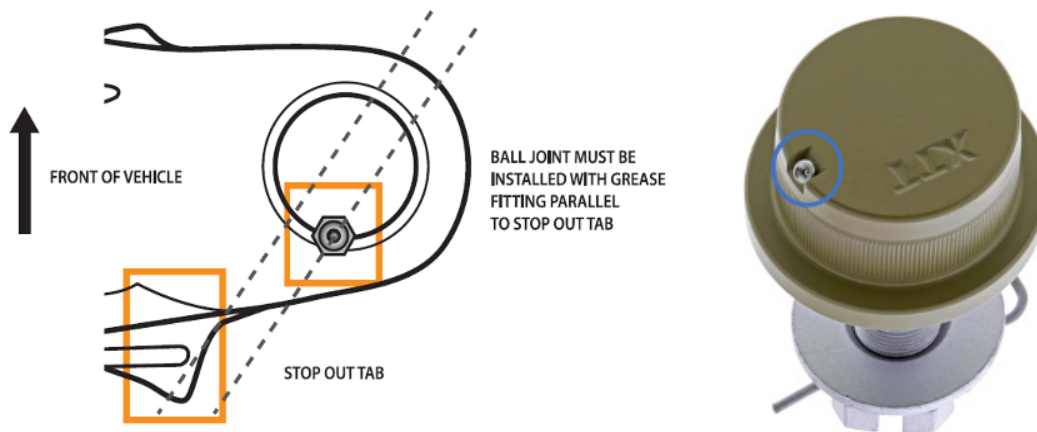
**Figure 1.** To ensure adequate clearance between components, ball joint must be installed with grease fitting parallel to lower stop out tab

To ensure adequate access to the grease fitting, the below noted ball joint must be pressed-in using the correct orientation.

- Before installation of ball joint, ensure all mating surfaces are clear of rust, debris and burrs.
- Verify press-in diameters and stud tolerances, including on steering knuckle side. Inspect mating surfaces for cracks, deformation and or an out of round condition. Replace all damaged or out-of-specification mating components.
- The ball joint must be installed with the grease fitting in parallel with the lower axle stop out tab. See Figure 1.
- Before press-in, it is recommended to create an index mark on both axle and ball joint housing using a suitable implement, such as a grease pencil. This will assist in attaining correct orientation during press-in.
