Correct Installation Orientation: 2020-2007 Lexus Sedan & Coupe Front Lower Ball Joint

Brand	Supreme	Product	Ball Joint	Date	October 2021
Part Number(s)	MK500126

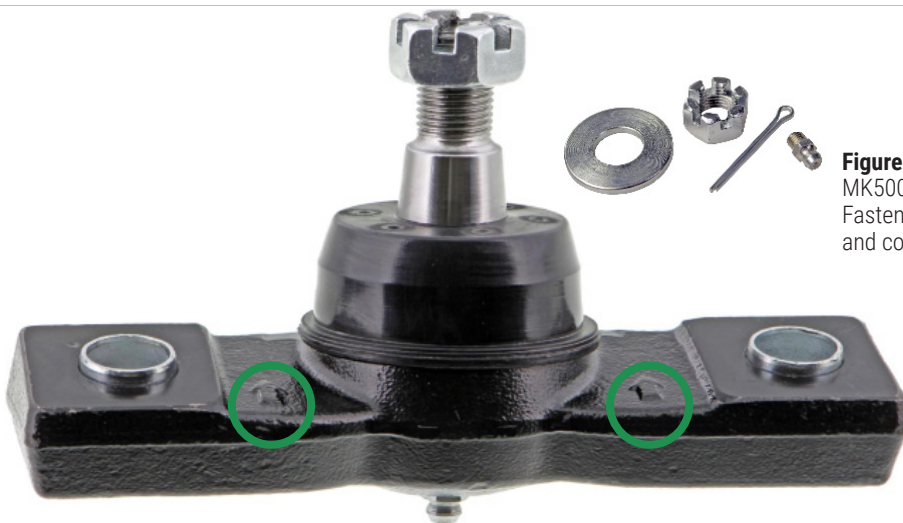
Figure 1. Mevotech Supreme ball joint MK500126 with directional indicators. Fastening hardware is also included for a quick and complete installation.

To ensure proper part performance, the ball joint noted below must be installed using the correct orientation when mating to the steering knuckle.

- Ensure all mating surfaces are clear of rust, debris and burrs. Inspect steering knuckle and control arm bores for cracks, deformation and/or an out-of-round condition. Do not reuse steering knuckle or control arm if these are found.
- Do not reuse old fastening hardware. Ensure to always replace fastening hardware.
- Control arm ball joint seating insert may become seized to old ball joint stud during removal. If the insert must be removed from the ball joint stud for reuse, it must be separated carefully. Do not reuse the insert if signs of damage or abnormal wear are found.
- Mevotech Supreme ball joint MK500126 includes useful directional indicator arrows cast onto the housing for easier installation. Locate these arrows. **See Figure 1.**
- Correct installation orientation is achieved when these arrows point INBOARD (towards vehicle motor).
