## Front Stabilizer Bar Link Installation: 2017-2012 Tesla Model S RWD

<b>Brand</b>	Supreme	<b>Product</b>	Stabilizer Bar Link	<b>Date</b>	July 2021
<b>Part Number(s)</b>	MS95808/MS95809

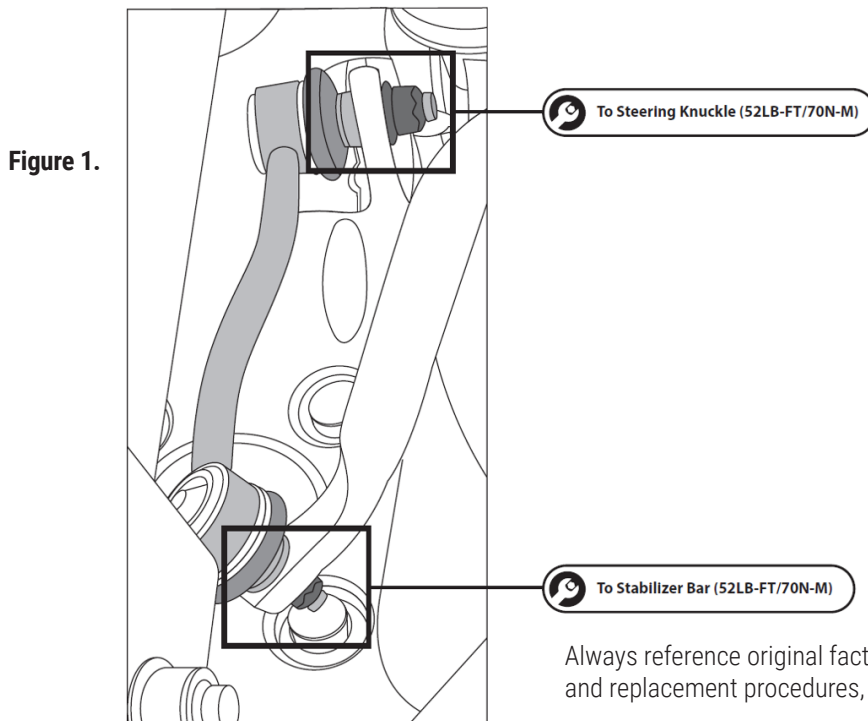
- See **Figure 1** for stabilizer bar link to steering knuckle and stabilizer bar fastening values.
