Rear Knuckle Toe Link Ball Joint: 2019-2011 Ford Explorer & 2019-2013 Police Interceptor Utility

Brand	Supreme	Product	Lateral Links	Date	August 2021
Part Number(s)	CMS40184

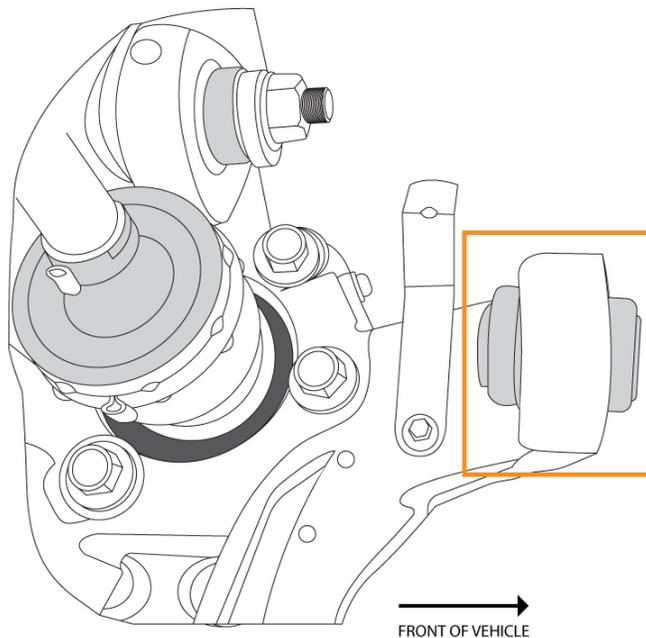
Figure 1. Location of cross-axis bushing on rear knuckle.

When replacing the rear knuckle toe link on the applications below it is imperative to inspect the mating cross-axis bushing (also referred to as ball joint), which is pressed into the knuckle. This is especially important in high-salt and/or high-corrosion operating environments. For location of cross-axis bushing, **see Figure 1**.

An out-of-specification cross-axis bushing may put excessive loading stresses on the new replacement toe link, leading to diminished performance.
