## Rear Stabilizer Bar Link Installation - 2016-2020 Hyundai and KIA SUVs

<b>Publication:</b>	MI-21-044-01-01-E	<b>Product</b>	Stabilizer Bar Link	<b>Date</b>	February 2021
<b>Part Number(s)</b>	MS908100

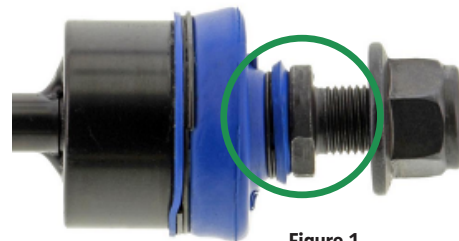
Figure 1

Due to limited working space on the rear of some 2016-2020 Hyundai and KIA SUVs, it may be possible to incorrectly install the rear stabilizer bar link. It is important to note that the rear lower control arm includes a slotted keyway as the mating point, which may not be visually apparent from underneath the vehicle. This may be overlooked during part replacement, leading to premature failure and/or degraded performance of the part.
