Issue: Correct Ball Joint Installation Orientation to Ensure Grease Fitting Accessibility

Brand	TTX	Product	Ball Joint	Date	September 2020
Part Number(s)	TXMS50580

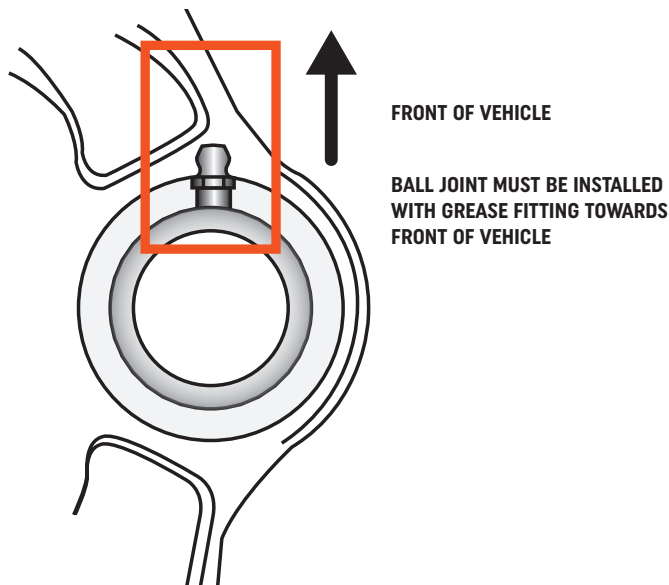
The ball joint must be installed with the grease fitting facing front of vehicle. This will ensure sufficient clearance for any future lubrication service. **See Figure 1.**

Figure 1: Correct Ball Joint Installation Orientation

For applications associated with this part number and which feature the OEM stamped steel front lower control arm, this ball joint must be correctly orientated during installation to ensure adequate access to grease fitting.
