## 2022-2016 Toyota Tacoma Front Lower Control Arm Rubber Plug Identification

<b>Brand</b>	Supreme	<b>Product</b>	Control Arm	<b>Date</b>	August 2022
<b>Part Number(s)</b>	CMS861297/CMS861298

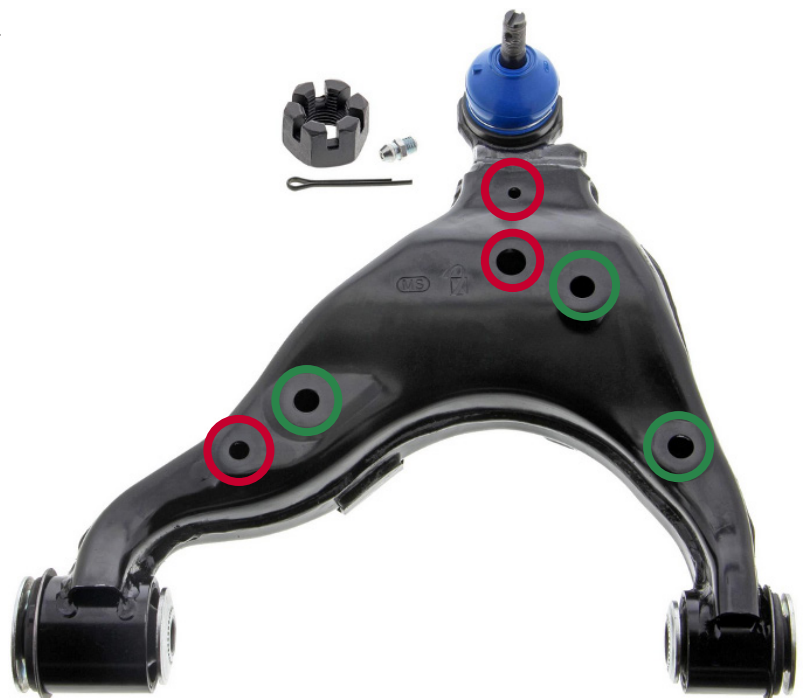
**Figure 1.** Correct rubber plug installation locations (circled in green). To ensure adequate drainage, do not cover or attempt to install plugs at locations circled in red

- Note the correct installation locations and then remove rubber plugs from originally equipped control arm.
- Inspect plugs for damage or out-of-specification condition. Do not reuse if is damaged, perforated or otherwise out-of-specification. If so, order replacement plugs from the OEM.
- Install plugs onto Mevotech replacement control arm.
