2009-2005 Nissan 350Z and 2007-2005 Infiniti G35 Front Lower Ball Joint Tapered Sleeve

Brand	Supreme	Product	Ball Joint and Control Arm	Date	November 2022
Part Number(s)	MS30506/CMS301030/CMS301031

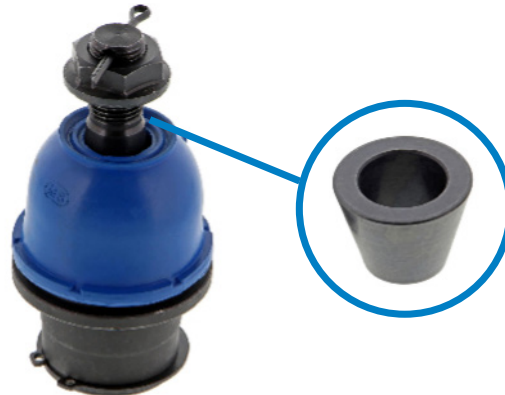
Occasionally, when separating the front lower forward control arm from the front lower ball joint, the tapered sleeve will become seized to the ball joint stud. This will lead to the above-mentioned visual discrepancy. **See Figure 1.**

Figure 1. Tapered sleeve (circled) may become seized to the ball joint stud, and when compared to the new replacement part cause a visual difference between the two. Mevotech Supreme ball joint MS30506 is anti-corrosion coated to reduce potential of seizing.

It is important to adhere to the factory service manual for all removal procedures when separating a control arm or ball joint which uses a sleeve. Often, a special tool will be required or specified to retain the sleeve in the control arm bore as the ball joint portion is removed.

If the sleeve must be removed from the ball joint stud for re-use, it must be separated carefully. A combination of penetrating oil and a three-jaw puller will usually suffice. All rust and corrosion must be cleaned from the sleeve and control arm bore. Additionally, the sleeve and mating component must be inspected for any damage and or an 'out-of-round' condition. Do not re-use the sleeve or mating component if signs of damage or abnormal wear are found during inspection.
