MEVOTECH INSIDER

Service Tips and Best Practices

BMW Front Lower Thrust Arm Bushings

Brand	Supreme	Product	Control Arm Bushings	Date	January 2020
Part Number(s)	Various

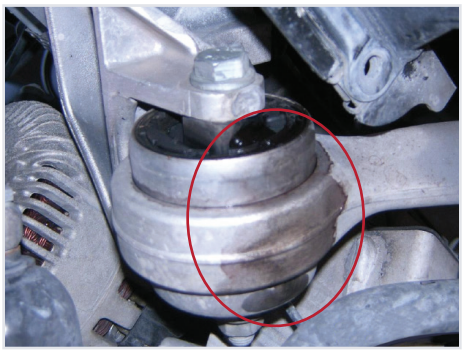
It is up to the technician to determine if the entire thrust arm must be replaced due to excessive "play" in the ball joint or if just the bushings are to be renewed. Generally, the bushing rubber will crack and tear. Additionally, on some BMW models, this bushing is filled with a hydraulic fluid; which will leak once the rubber has torn. These failure modes can be verified by a visual inspection. Do note that solely manipulating the wheels and thrust arm for "play" may not indicate thrust arm bushing failure; both worn and new bushings may appear to have similar movements.

Figure 1: Hydraulic fluid leaking from bushing. One indicator of failed bushing.

- Thrust arm bushings must be replaced in pairs.
- Thrust arm bushings cannot be replaced more than once on an arm. This is due to enlargement of the bore. If a vehicle encounters repeated bushing failures in a short span of time, inspect for wear, distortion/damage to suspension components and verify vehicle alignment.
- Use the factory tool for removal and installation. Aftermarket tools may not have the correctly sized press/receiver cups which may warp or otherwise damage the thrust arm bore.
- The factory tool will help ensure the bushing is even and square on the proper install axis. Correct seating and alignment are critical to part life longevity.

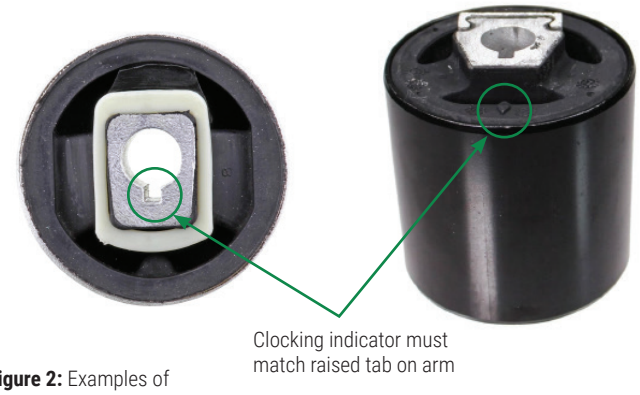
Figure 1: One type of clocking indicator

Figure 2: Examples of Clocking Indicators

- Do not use a heat source to aid in removal. This can warp/distort or otherwise damage the thrust arm bore and or ear; especially if aluminum.
- Do not use a hammer or apply blunt force to aid in removal or installation. This can warp/distort or otherwise damage the thrust arm bore and or ear; especially if aluminum.
- After removing the worn bushing, remove all rust, burrs and other contaminants from the bore. Inspect the bore and ear for abnormal wear, enlargement, "out of roundness" and or other damage before installation.
- Ensure correct orientation of bushing during install. Generally, this will mean locating the clocking indicator (this may be a notch or arrow) on the bushing face or sleeve and matching it to the raised tab on the arm. Depending on vehicle model, this indicator may be located on both sides or only one side of the bushing face or sleeve.
