MEVOTECH INSIDER
Service Tips and Best Practices

Correct Installation Orientation: 1997-1990 Honda Accord Front Upper Ball Joint

Brand	Supreme	Product	Ball Joint	Date	November 2022
Part Number(s)	MK90458

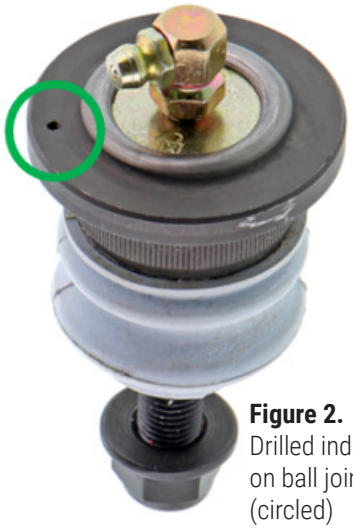
Figure 2. Drilled index mark on ball joint flange (circled)

- Verify press-in diameters and stud tolerances, including on steering knuckle side. Replace all damaged or out-of-specification mating components.
- When pressing-in ball joint, ensure pressure is applied to the mounting flange and not the ball joint back plate. Contact with the back plate during install may lead to damage and or impaired performance of the ball joint.
- Locate drilled index mark on ball joint flange. **See Figure 2**.
- Before press-in, it is recommended to create an alignment mark on both control arm and ball joint housing using a suitable implement, such as a grease pencil. This will assist in attaining correct orientation during press-in.
