MEVOTECH INSIDER

Correct Installation Orientation: 2000-1996 GM 1500 Truck & 2500/3500 SUV Front Lower Ball Joint (Forged Arm)

Brand	Supreme	Product	Ball Joint	Date	April 2023
Part Number(s)	MK6509

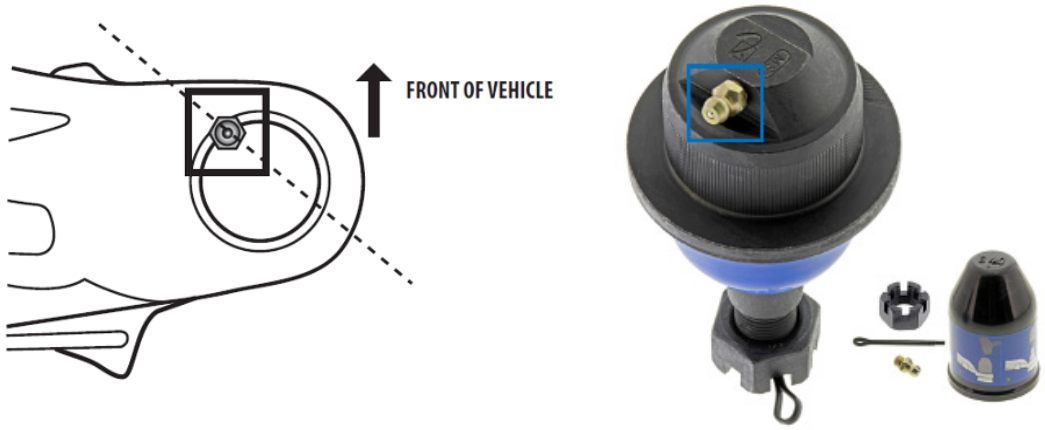
To ensure adequate access to the grease fitting for relubrication service, the below noted ball joint must be pressed-in using the correct orientation.

Figure 1. To ensure adequate clearance between components for relubrication service, ball joint must be installed with grease fitting positioned approximately 45° towards centerline of vehicle. A Bootstaller™ tool is included in the box to seat the dust boot securely and easily safter install.

- Before installation of ball joint, ensure all mating surfaces are clear of rust, debris and burrs.
- Verify press-in diameters and stud tolerances, including on steering knuckle side. Inspect mating surfaces for cracks, deformation and or an out of round condition. Replace all damaged or out-of-specification mating components.
- Correct orientation is achieved when grease fitting is located approximately 45° towards centerline of vehicle. Grease fitting must also be positioned towards front of vehicle. **See Figure 1**.
- Before press-in, it is recommended to create an index mark on both control arm body and ball joint housing using a suitable implement, such as a grease pencil. This will assist in attaining correct orientation during press-in.
